**A SCOPING STUDY OF WATER QUALITY CONDITIONS  
IN THE MISSOURI NATIONAL RECREATIONAL RIVER  
REACH FROM NEAR GAVINS POINT DAM TO PONCA  
STATE PARK, NEBRASKA**

**Water Quality Unit  
Water Control and Water Quality Section  
Hydrologic Engineering Branch  
Engineering Division  
Omaha District  
U.S. Army Corps of Engineers**

**March 2002**

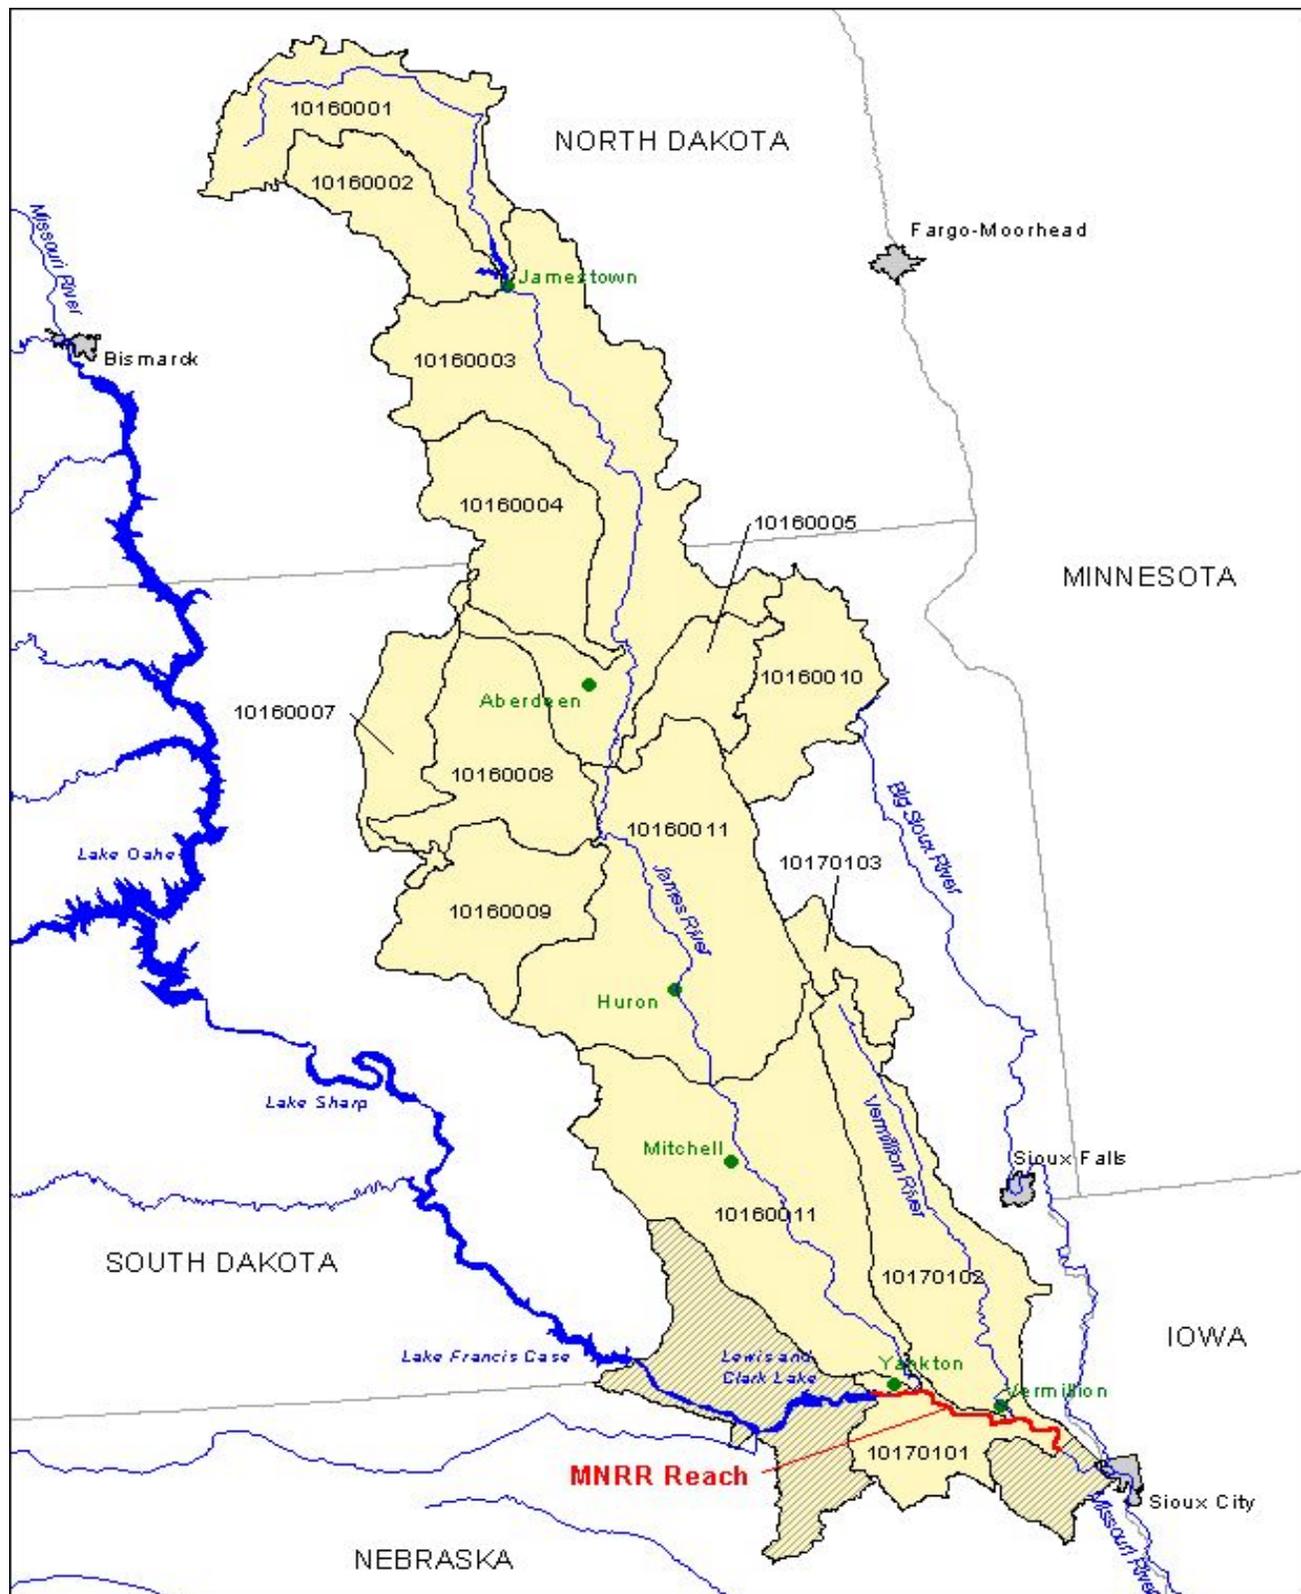
Plate 2. Watershed area draining to the MNRR reach below Gavins Point Dam as delineated by 8-digit Hydrologic Units (HUCs). Note: The "shaded" area of HUC 10170101 is the area above Gavins Point Dam and below Ponca, Nebraska that does not contribute runoff to the MNRR reach.

The 8-digit Hydrologic Units (HUCs) that make up the watershed of the MNRR reach below Gavins Point Dam are shown in Plate 2 and described in Table 1. The size of the watershed contributing runoff to the MNRR reach below Gavins Point Dam is approximately 25,120 square miles. Of the total 25,120 square mile watershed, approximately 21,590 square miles is in the James River watershed and approximately 2,650 square miles is in the Vermillion River watershed. Approximately 880 square miles is in the watersheds of the other tributaries discharging directly to the MNRR reach (mainly from tributaries in Nebraska). The coteau region, HUCs 10160007, 10160010, and 10170103 (2,530 square miles), are largely internally drained and generally non-contributing to surface water runoff within the watershed.

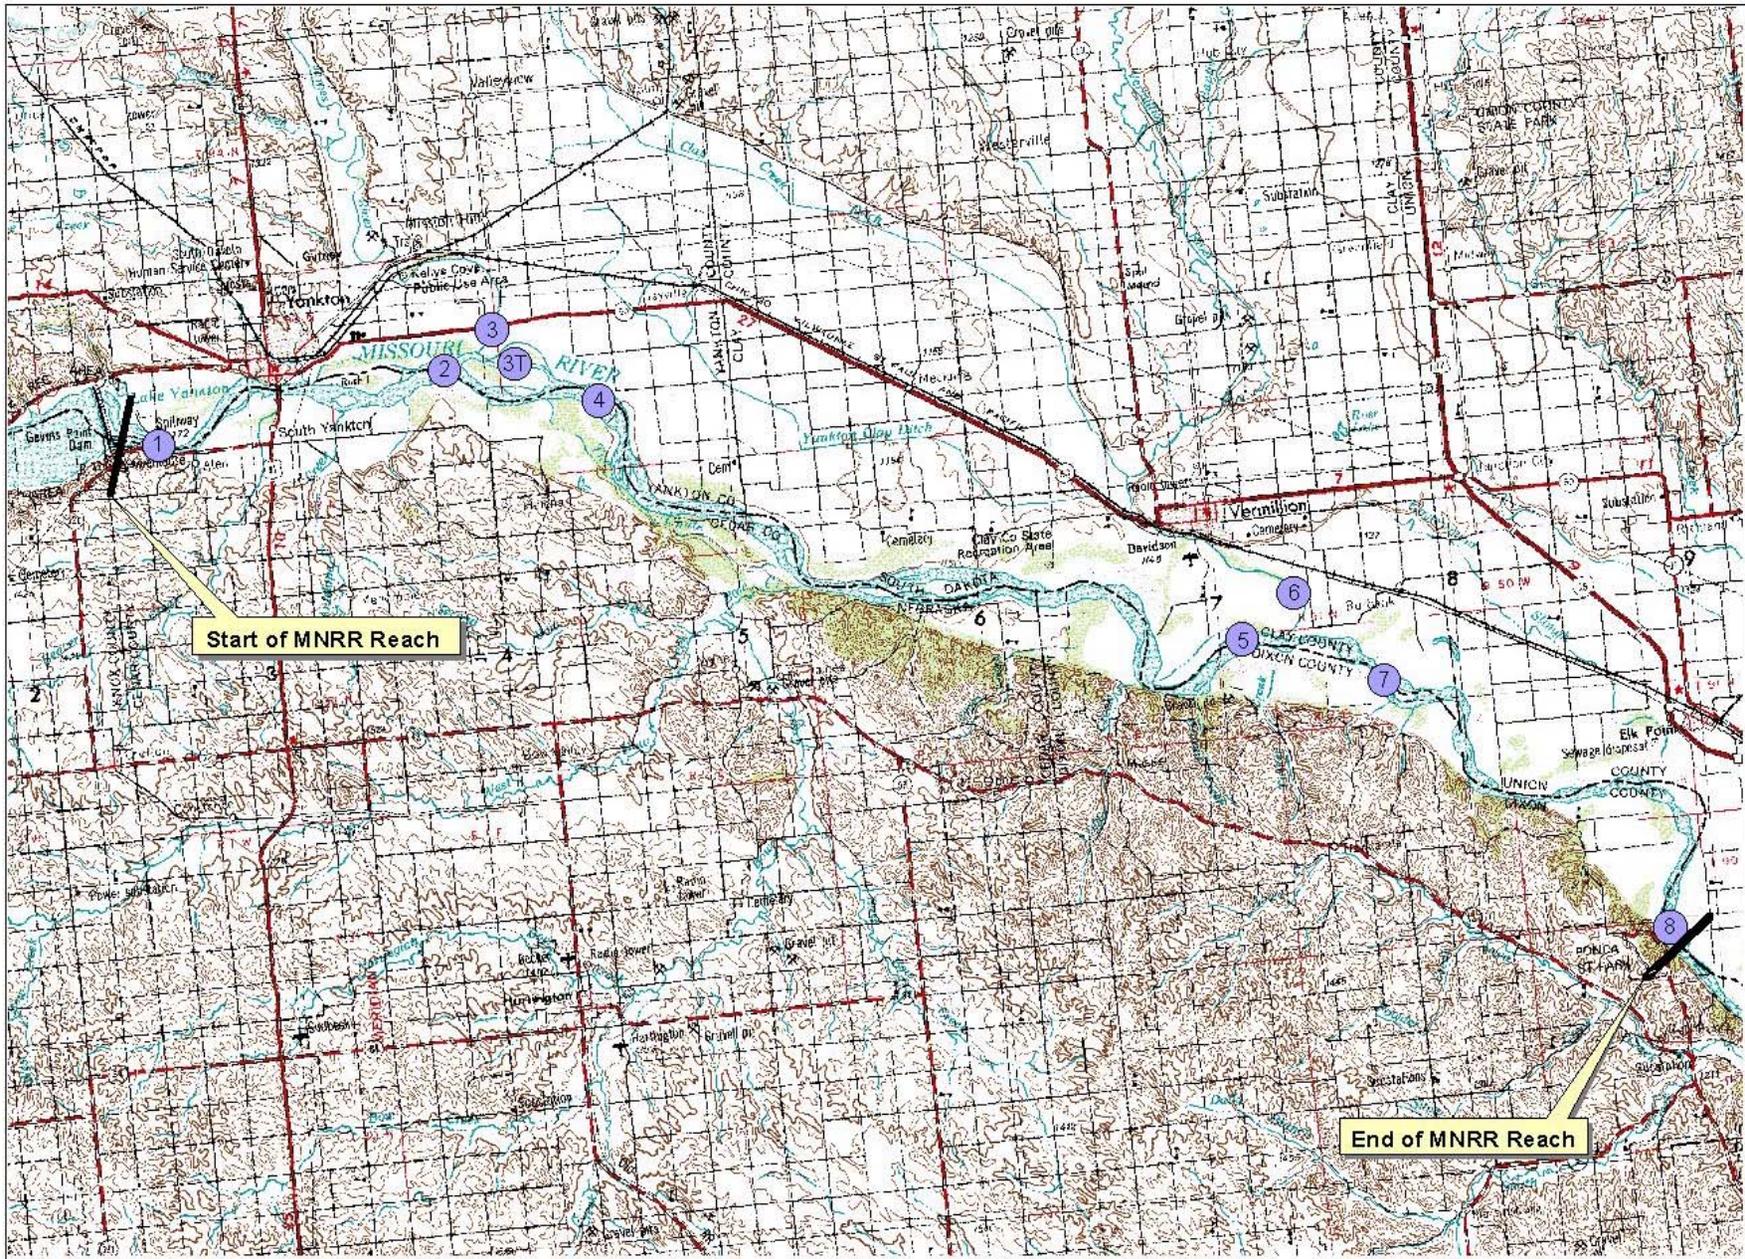
Plate 3. Location of monitoring sites along the MNRR reach where water quality samples were collected as part of the scoping study.

A total of nine monitoring locations were established on the Missouri, James, and Vermillion Rivers as part of the scoping study (Plate 3). Location 1 was on the Missouri River approximately 1 mile below Gavins point Dam at Missouri River Mile (RM) 810 and consisted of a thalweg site only (Plate 4). Location 2 was on the Missouri River, approximately 0.5 miles above the confluence of the James River at RM 801, and had both a thalweg and backwater site (Plate 5). Location 3 was on the James River approximately 0.5 miles upstream from the Missouri River, and water quality samples were collected at a single mid-channel site (Plate 5). Location 3T was located on a side channel of the Missouri River that received the inflow of the James River, and four sites (3T1, 3T2, 3T3, and 3T4) were sampled along an approximate 2 mile distance of the side channel downstream from the mouth of the James River (Plate 5). Location 4 was on the Missouri River, approximately 1 mile below where the side channel receiving the James River flow enters the main channel flow of the Missouri River at RM 797, and consisted of both a thalweg and backwater site (Plate 5). Location 5 was on the Missouri River approximately 1 mile upstream from the confluence of the Vermillion River at RM 774, and consisted of both a thalweg and backwater site (Plate 6). Location 6 was on the Vermillion River approximately 0.5 miles upstream of its confluence with the Missouri River and water quality samples were collected at a single mid-channel site (Plate 6). Location 7 was on the Missouri River, approximately 0.5 miles below the confluence of the Vermillion River at RM 771, and consisted of both a thalweg and backwater site (Plate 6). Location 8 was on the Missouri River at Ponca State Park, Nebraska at RM 753 and consisted of both a thalweg and backwater site (Plate 7).

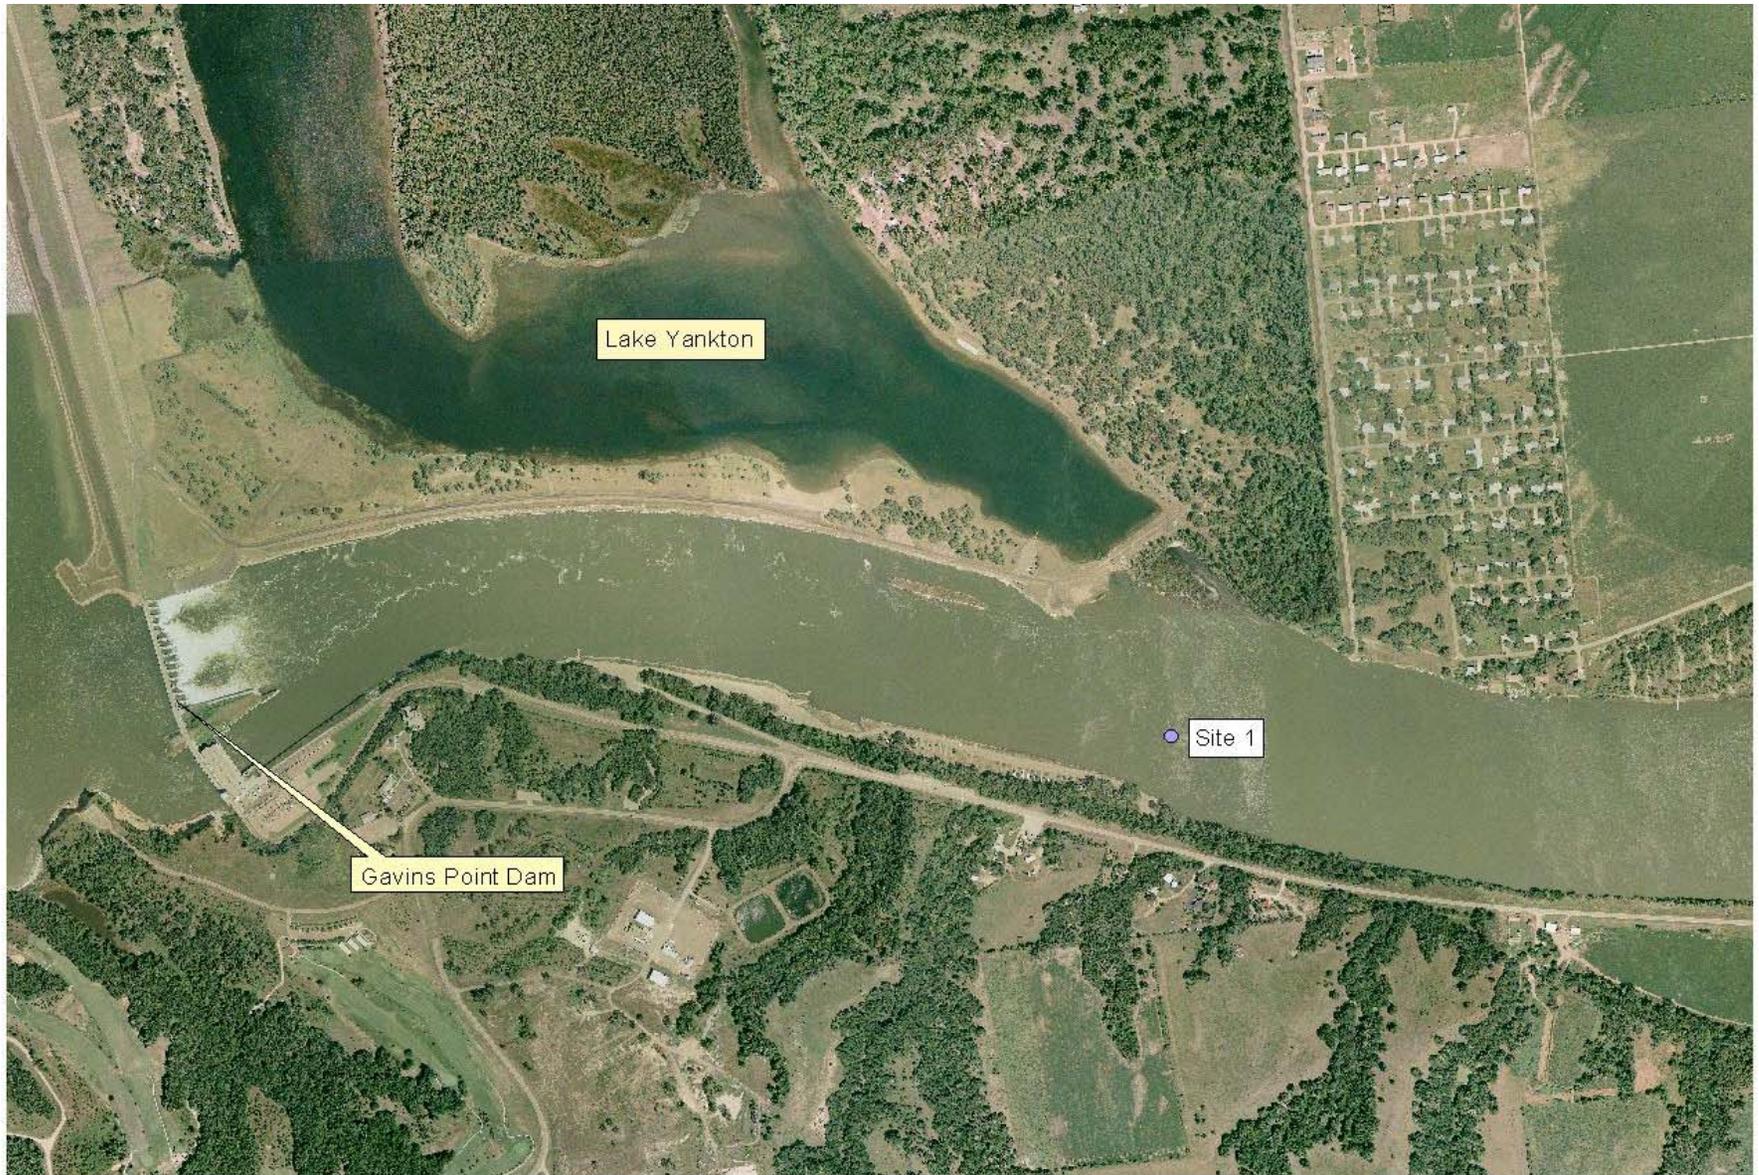
**Plate 4.** Location of Site 1 based on the average of the obtained GPS coordinates and projected on a 1997 orthophoto of the area.

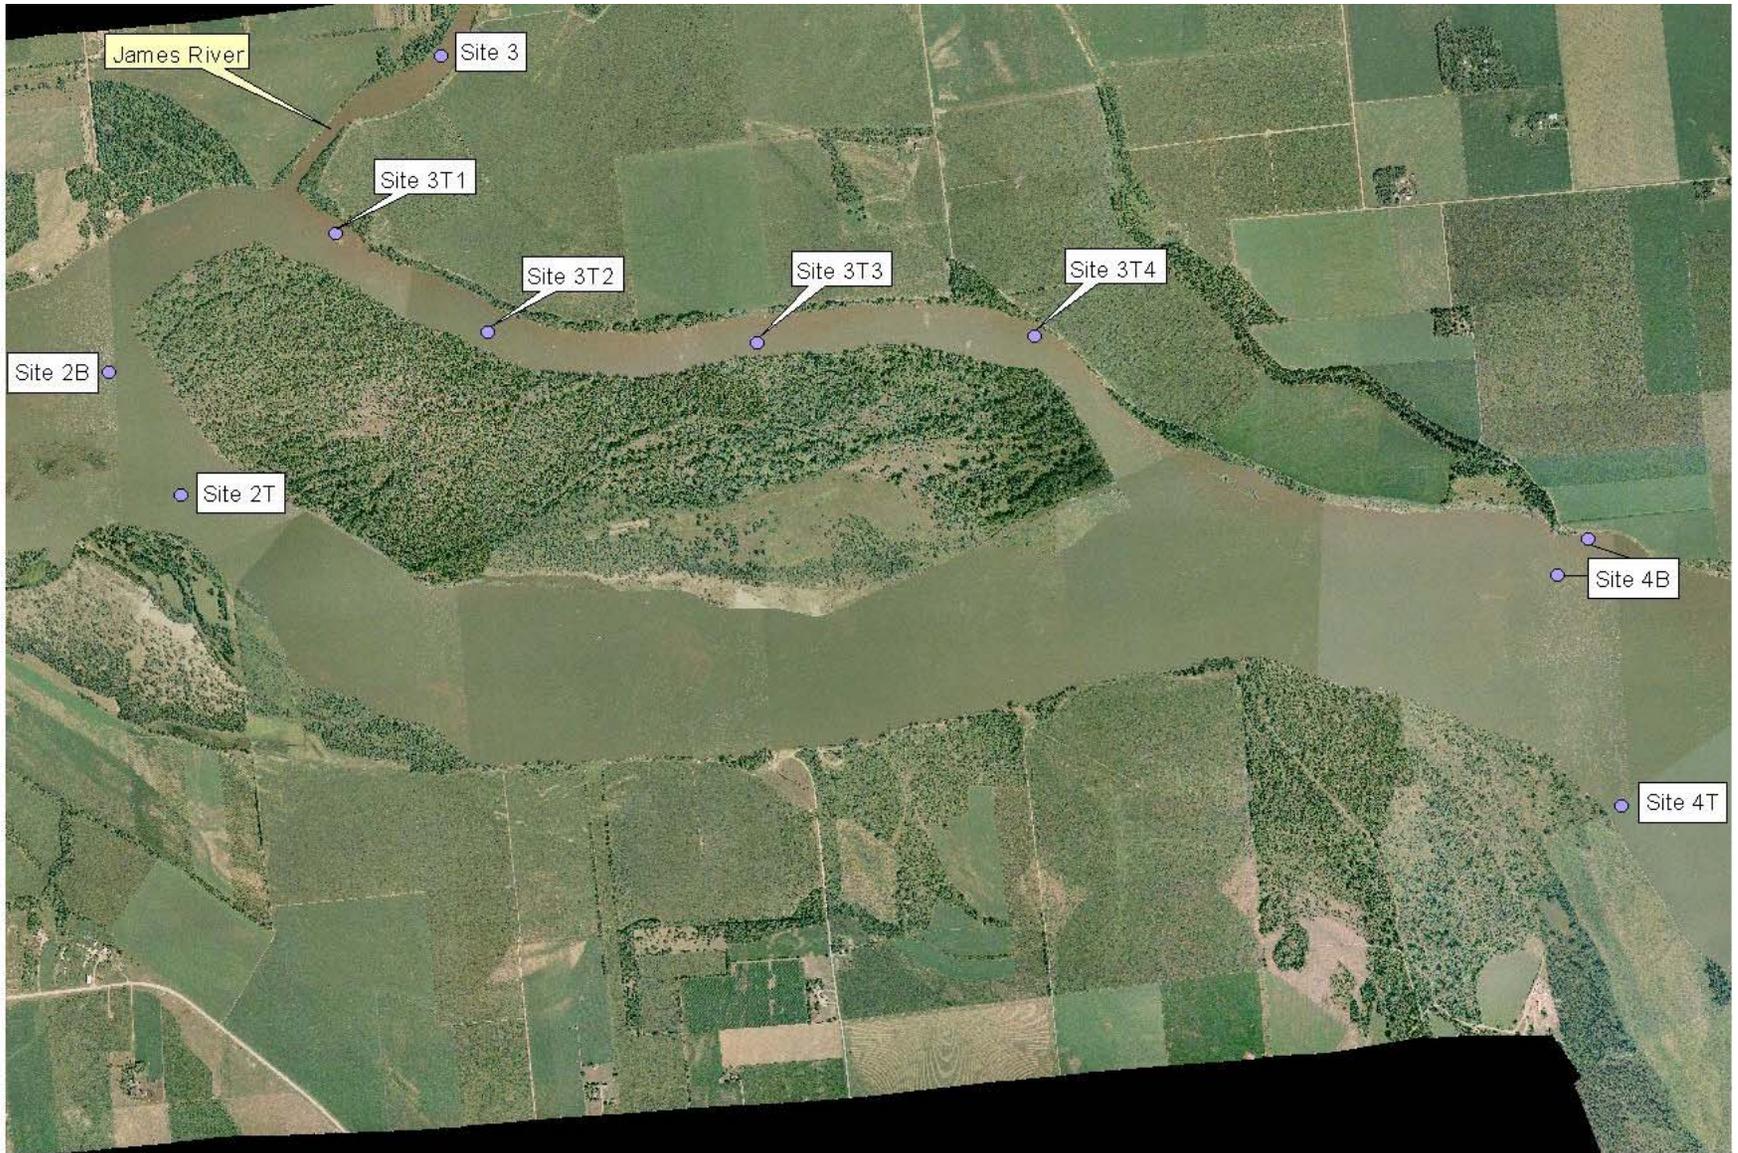
**Plate 5.** Location of Sites 2B, 2T, 3, 3T1, 3T2, 3T3, 3T4, 4B, and 4T based on the average of the obtained GPS coordinates and projected on a 1997 orthophoto of the area.

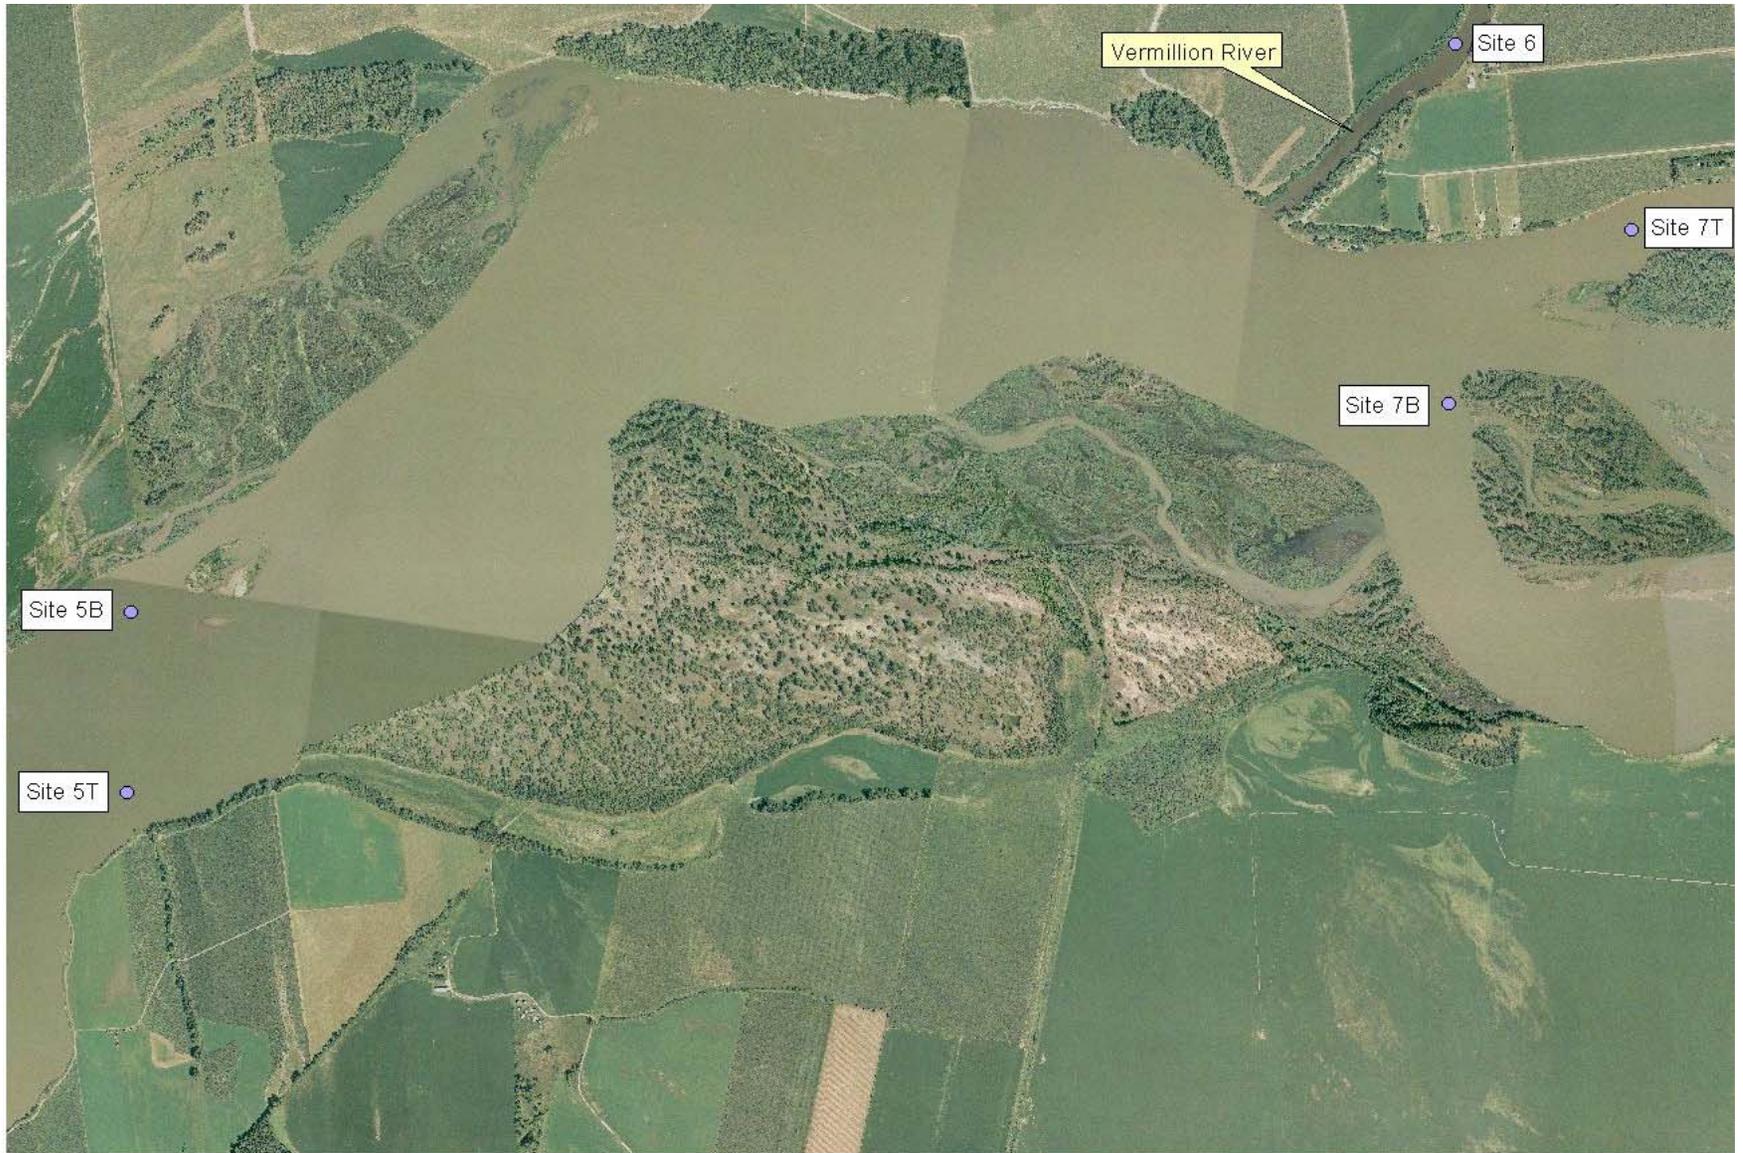
**Plate 6.** Location of Sites 5B, 5T, 6, 7B, and 7T based on the average of the obtained GPS coordinates and projected on a 1997 orthophoto of the area.

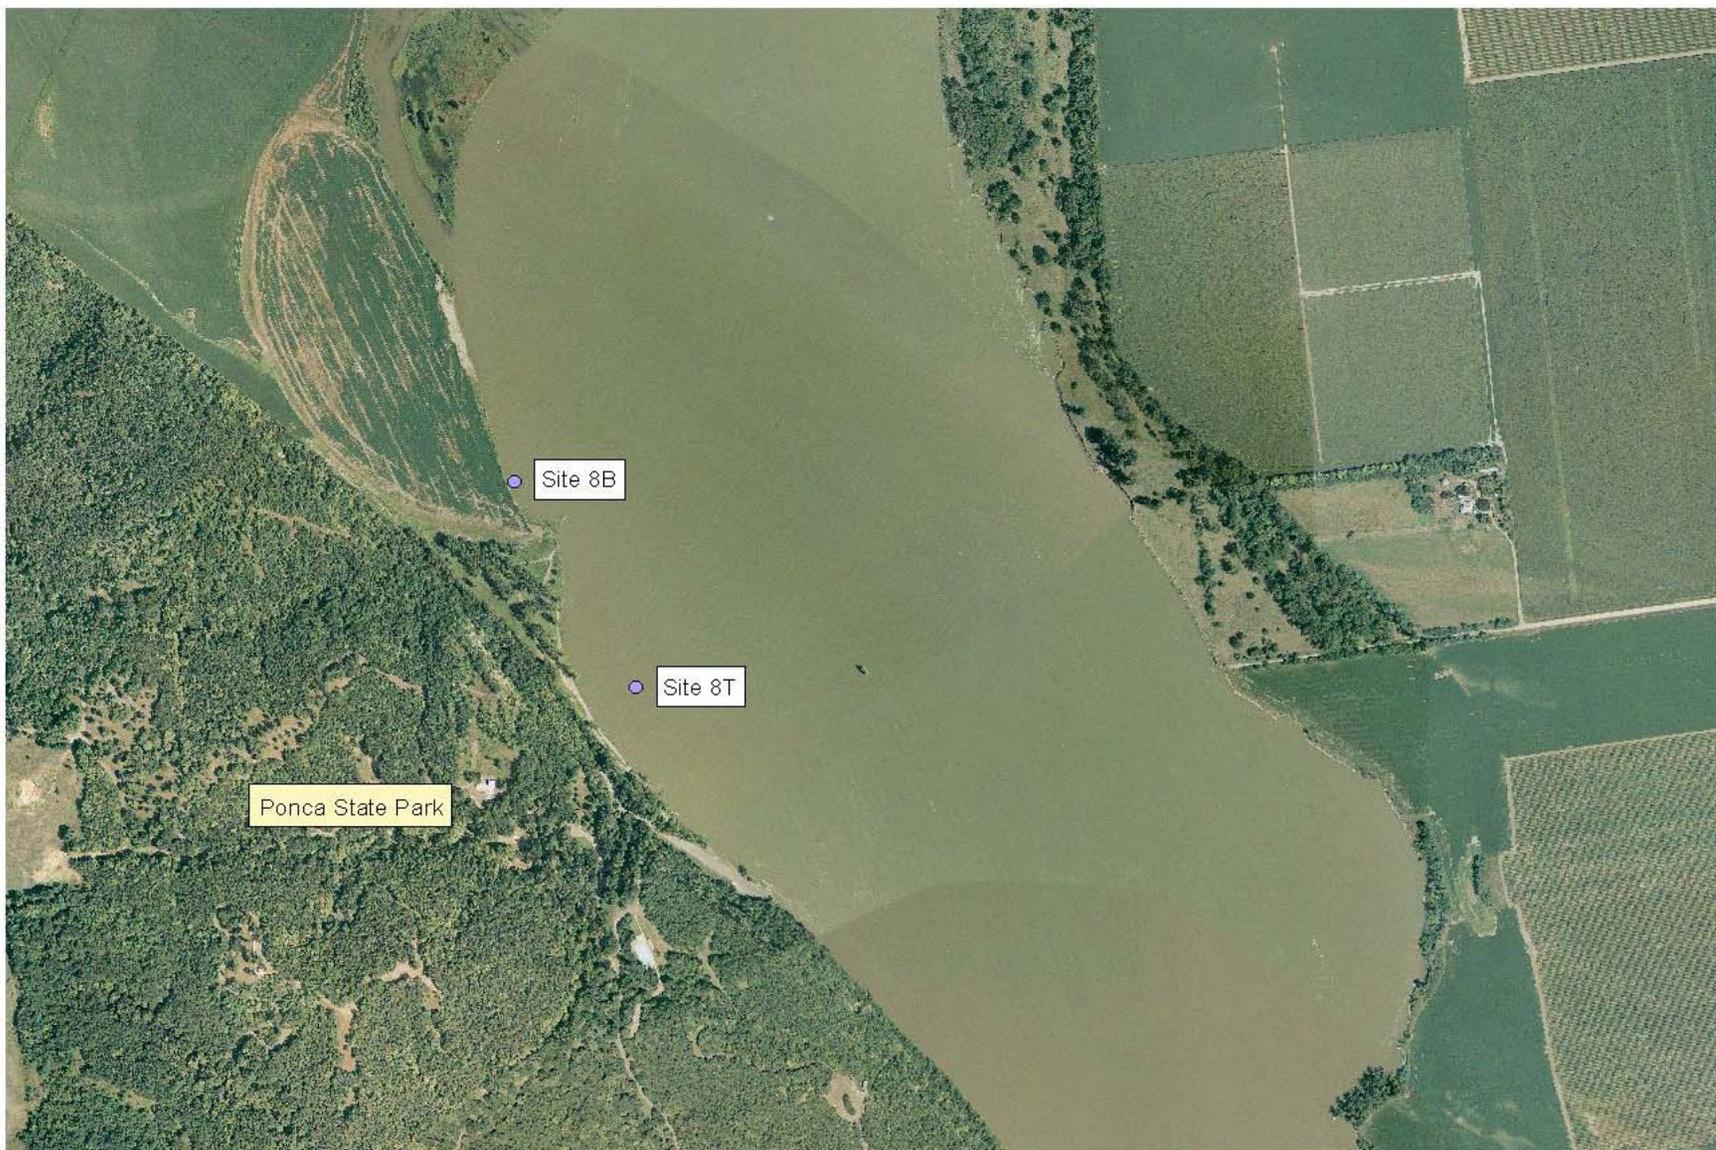
**Plate 7.** Location of Sites 8B and 8T based on the average of the obtained GPS coordinates and projected on a 1997 orthophoto of the area.

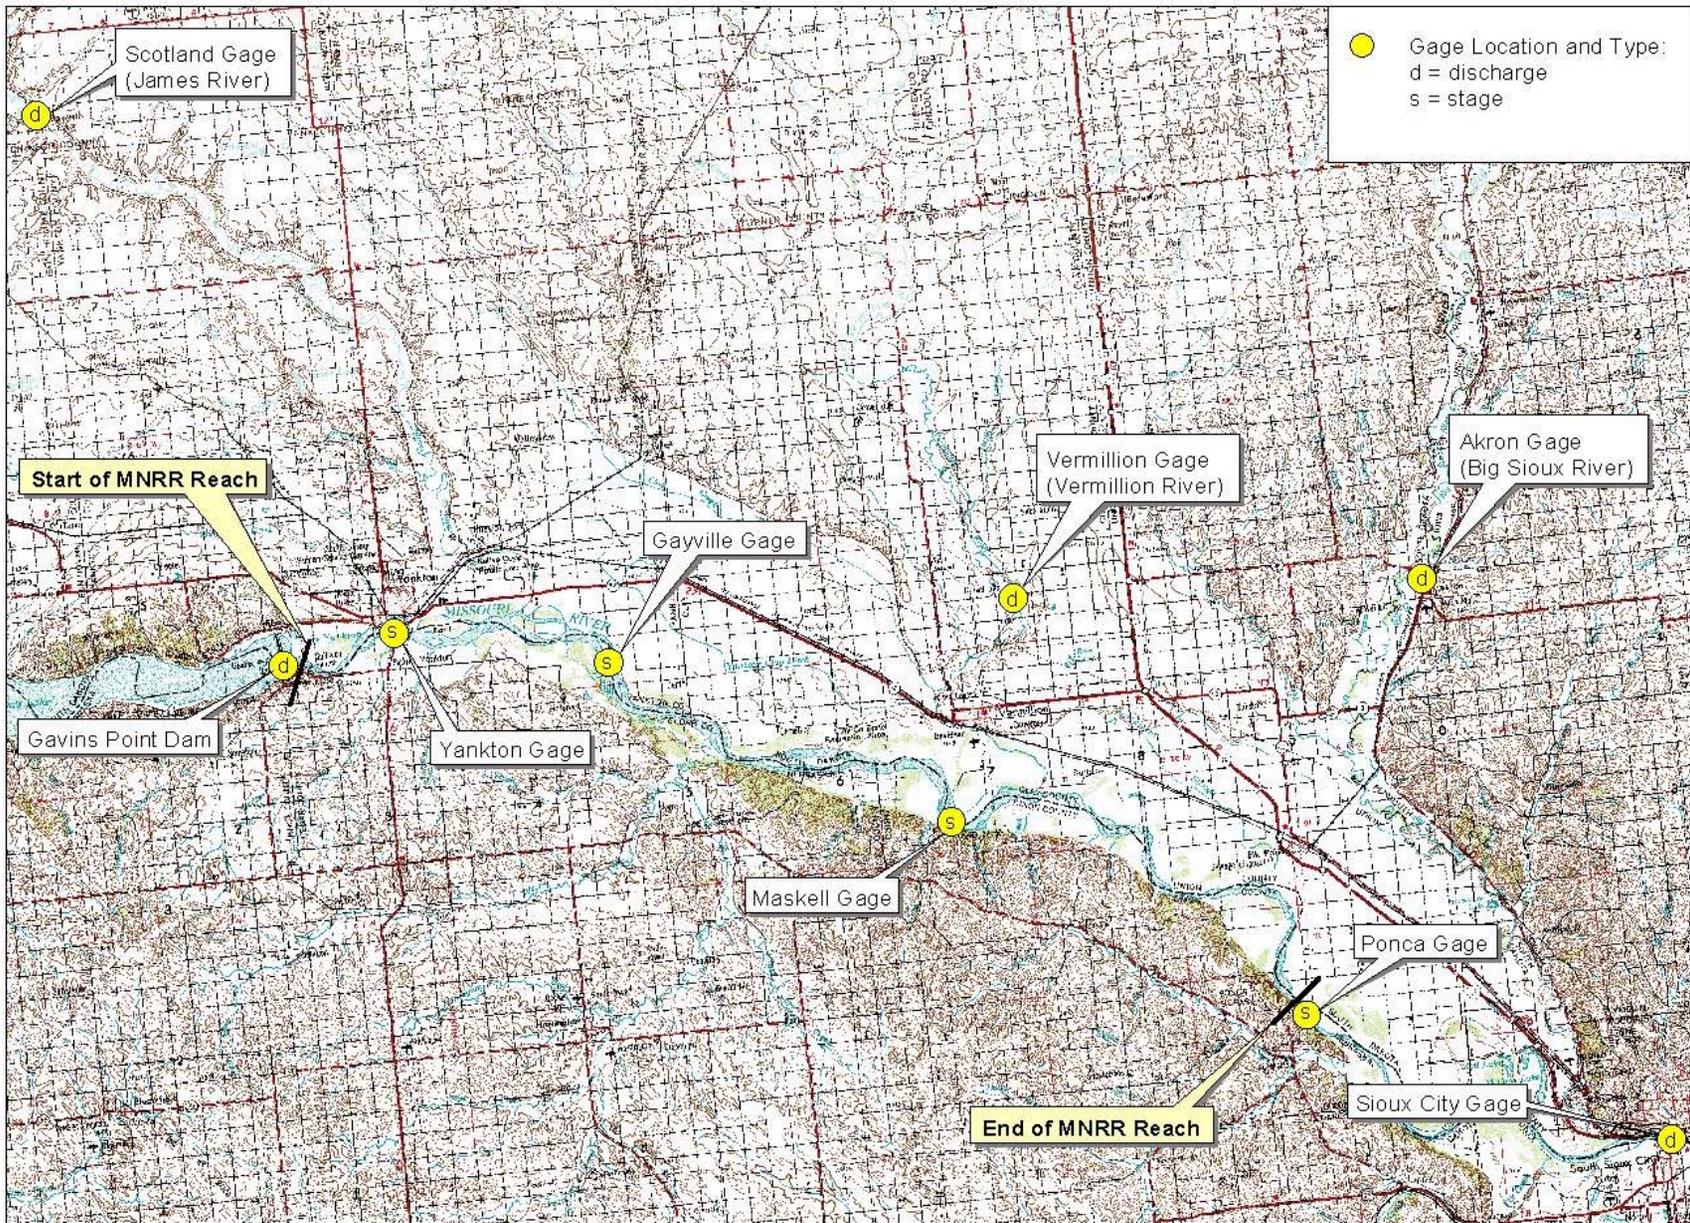
Plate 8. Location of gaging stations along and in proximity to the MNRR reach.
