**A SCOPING STUDY OF WATER QUALITY CONDITIONS  
IN THE MISSOURI NATIONAL RECREATIONAL RIVER  
REACH FROM NEAR GAVINS POINT DAM TO PONCA  
STATE PARK, NEBRASKA**

**Water Quality Unit  
Water Control and Water Quality Section  
Hydrologic Engineering Branch  
Engineering Division  
Omaha District  
U.S. Army Corps of Engineers**

**March 2002**

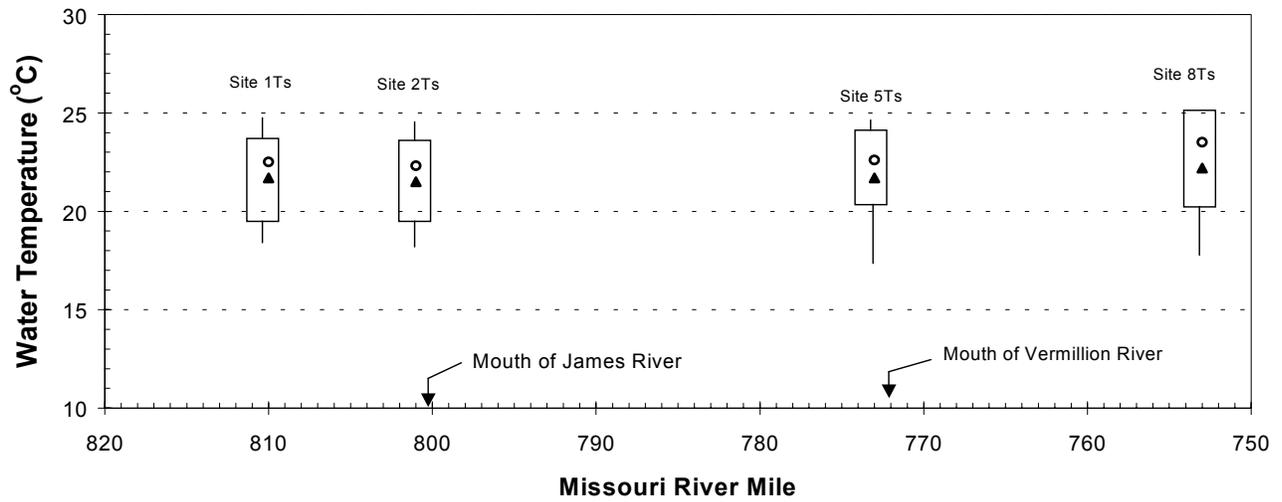
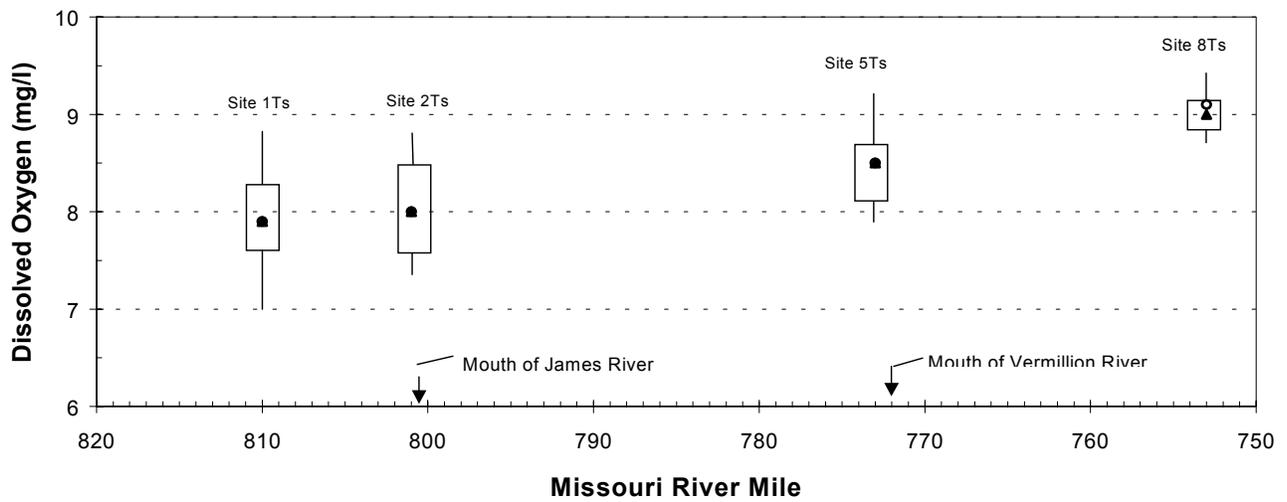
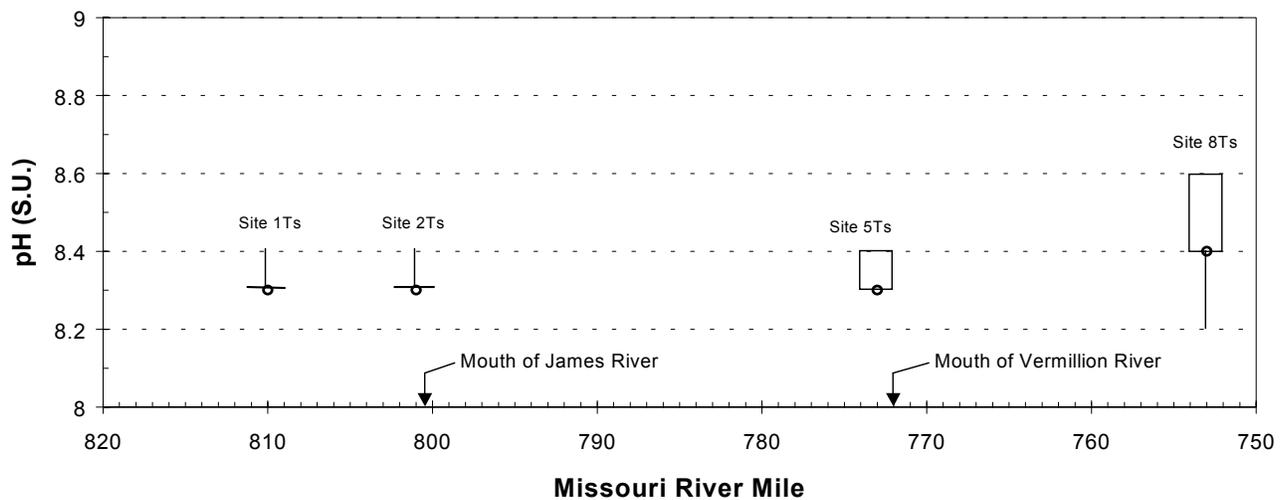
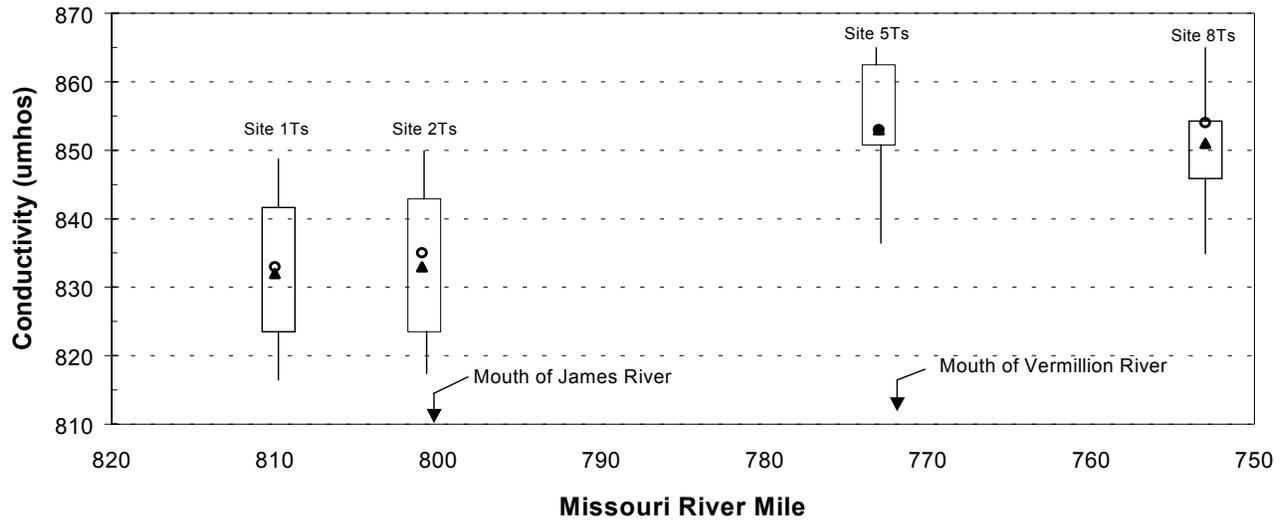
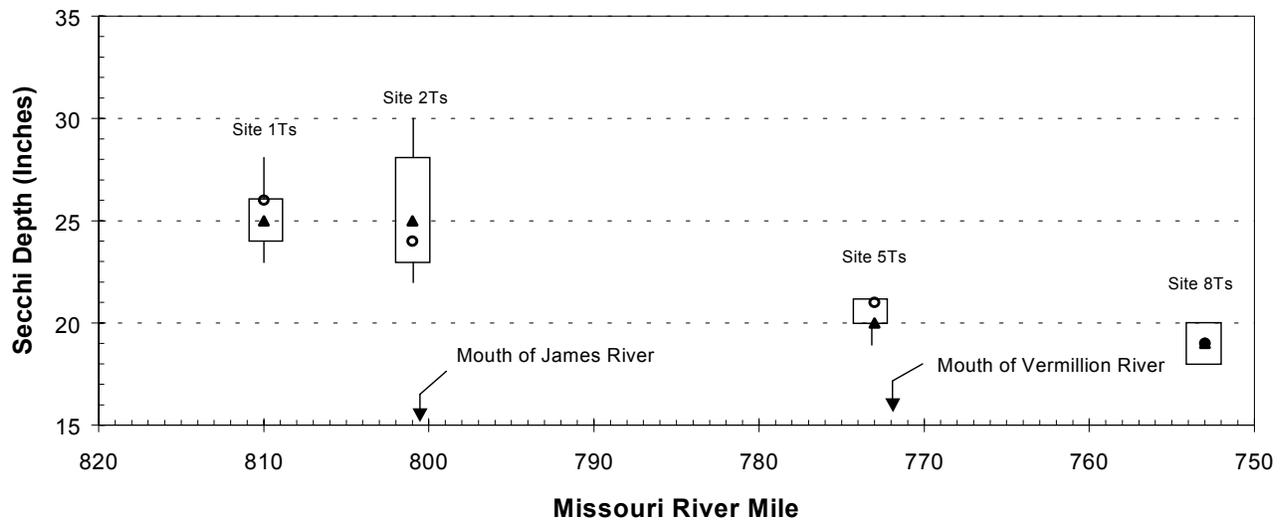
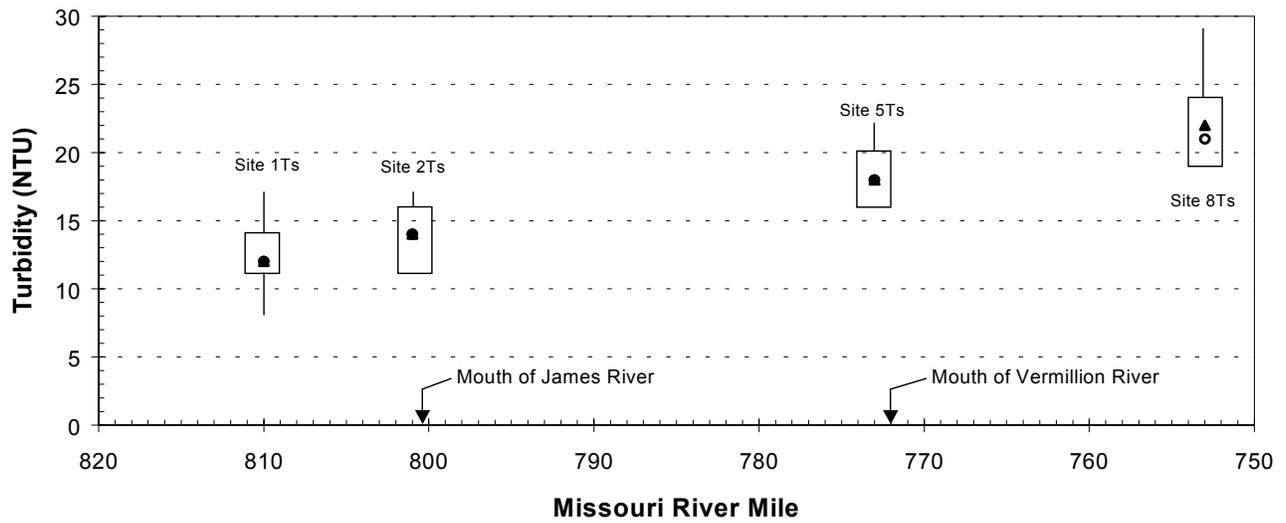
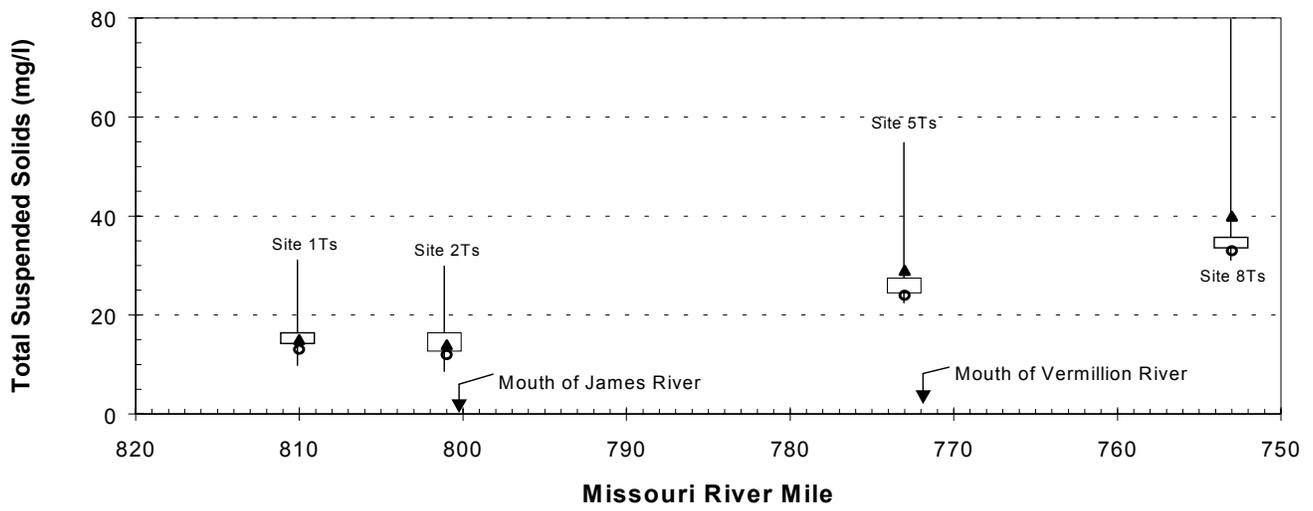
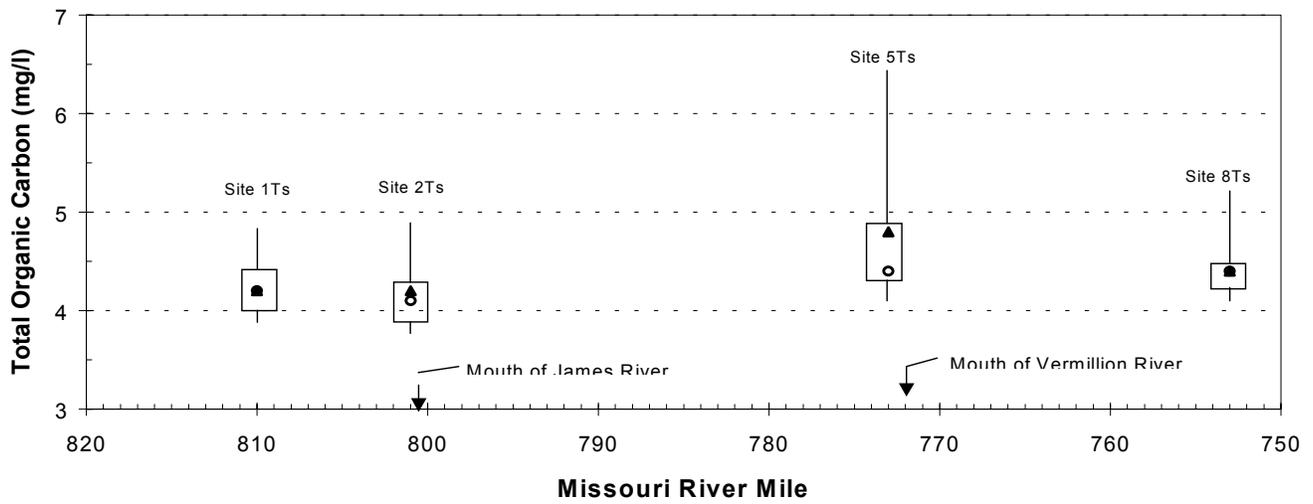
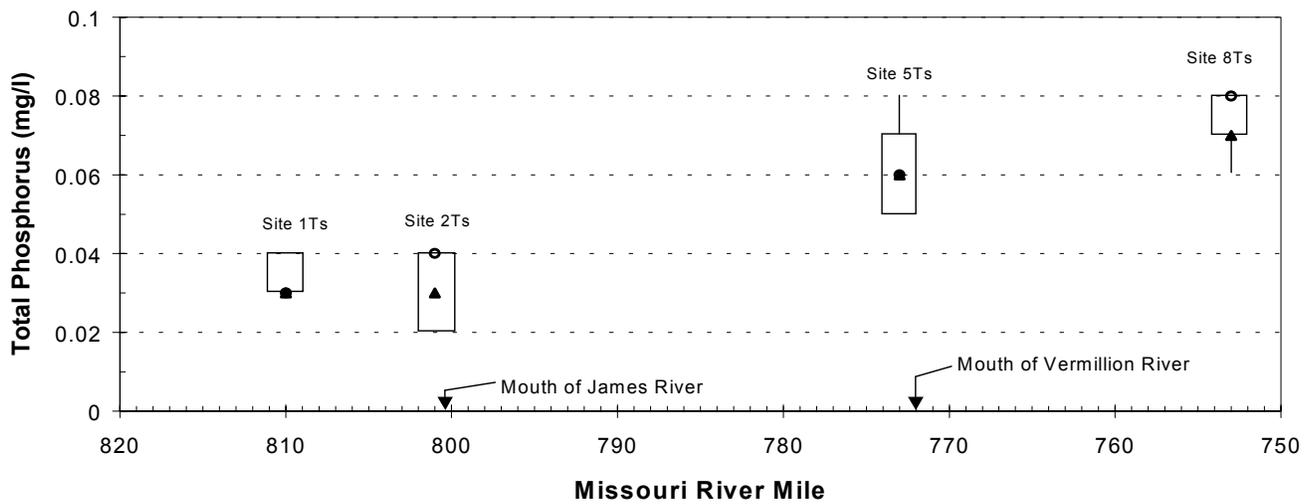
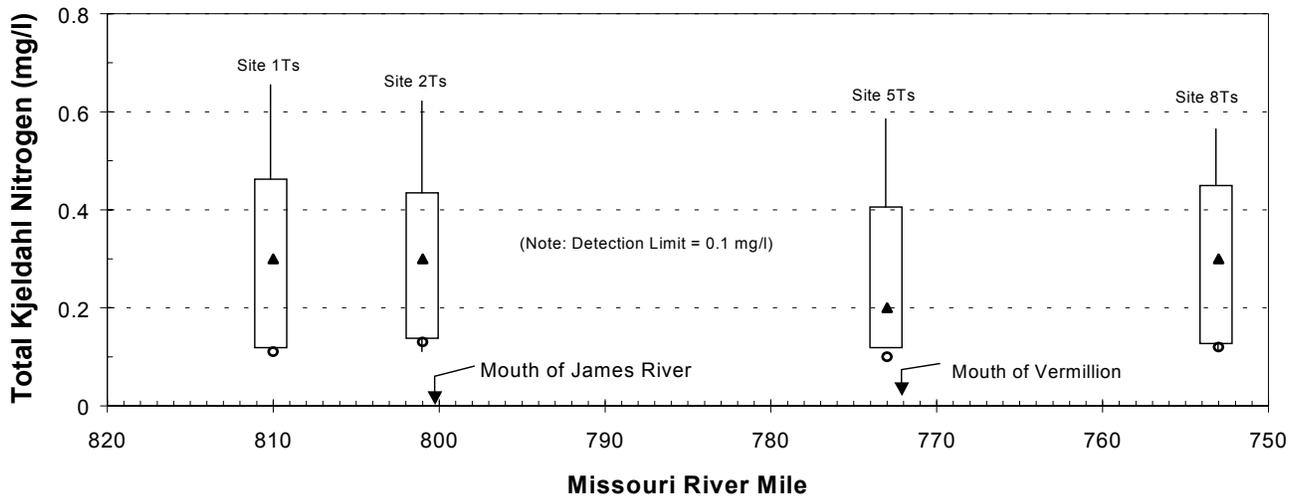
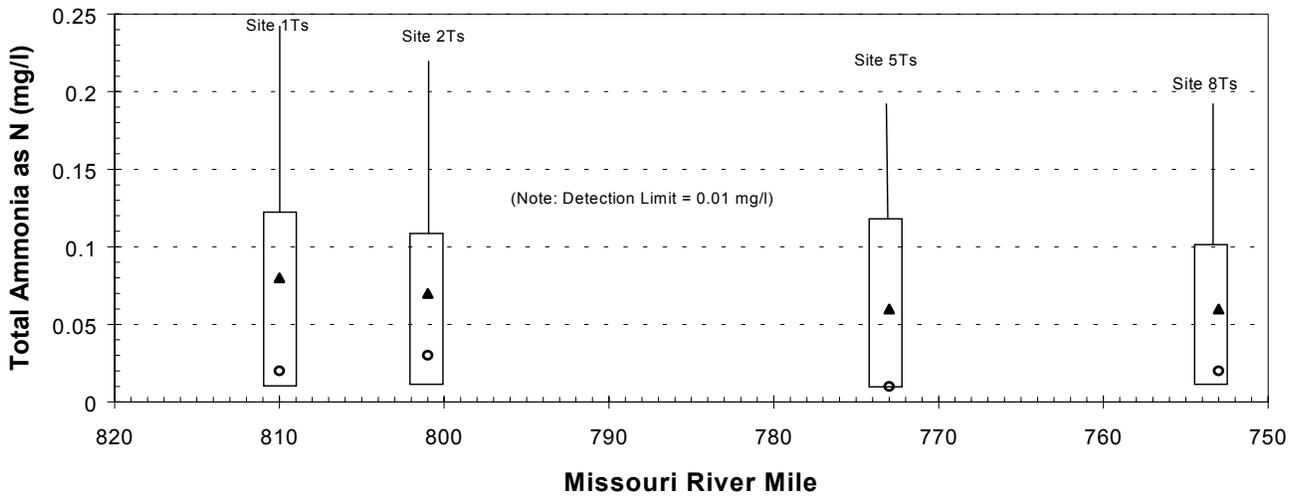
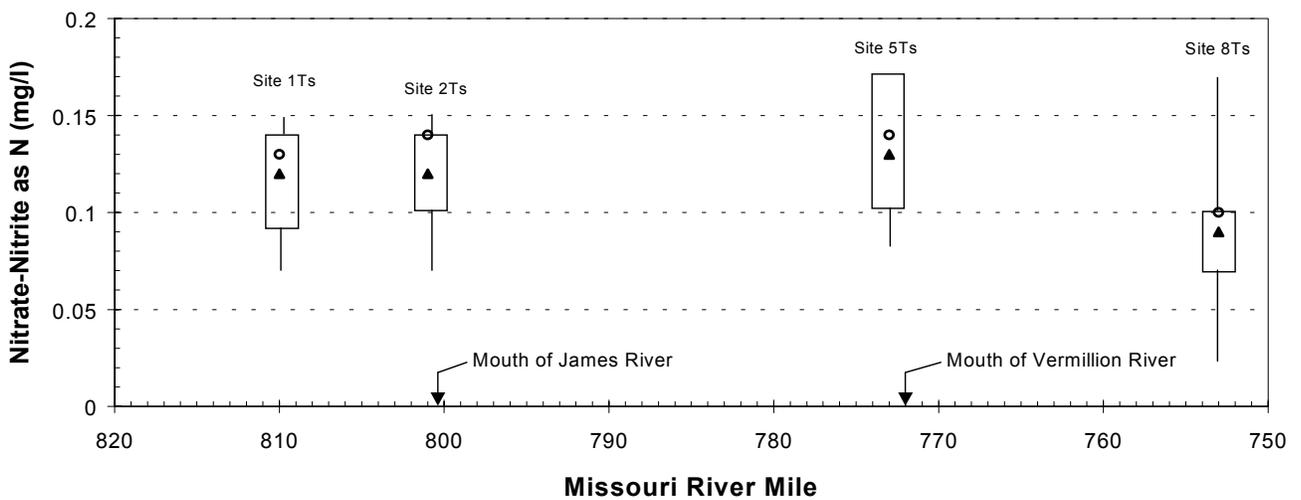
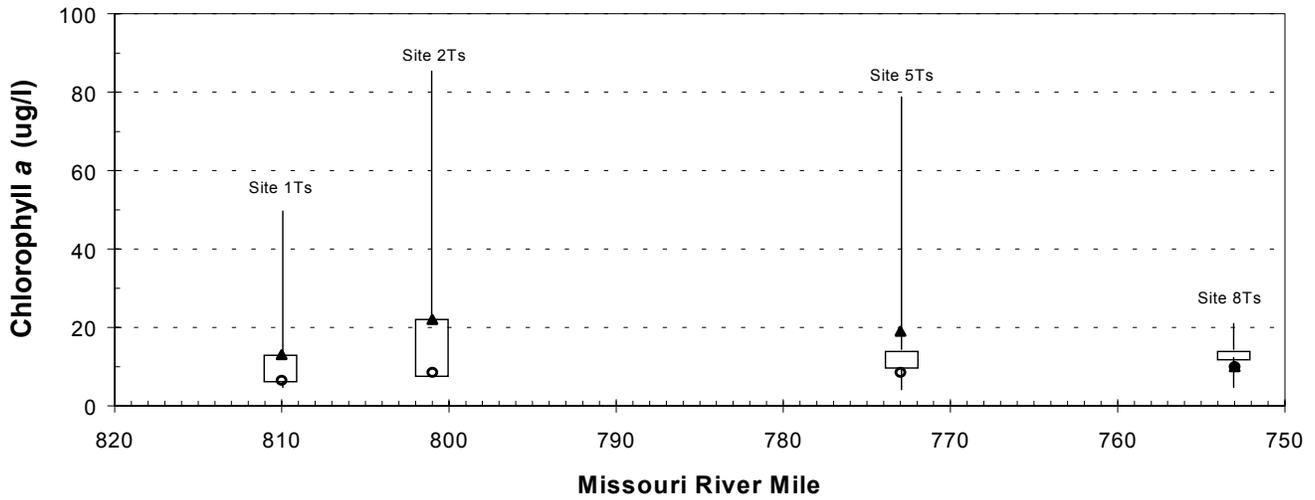
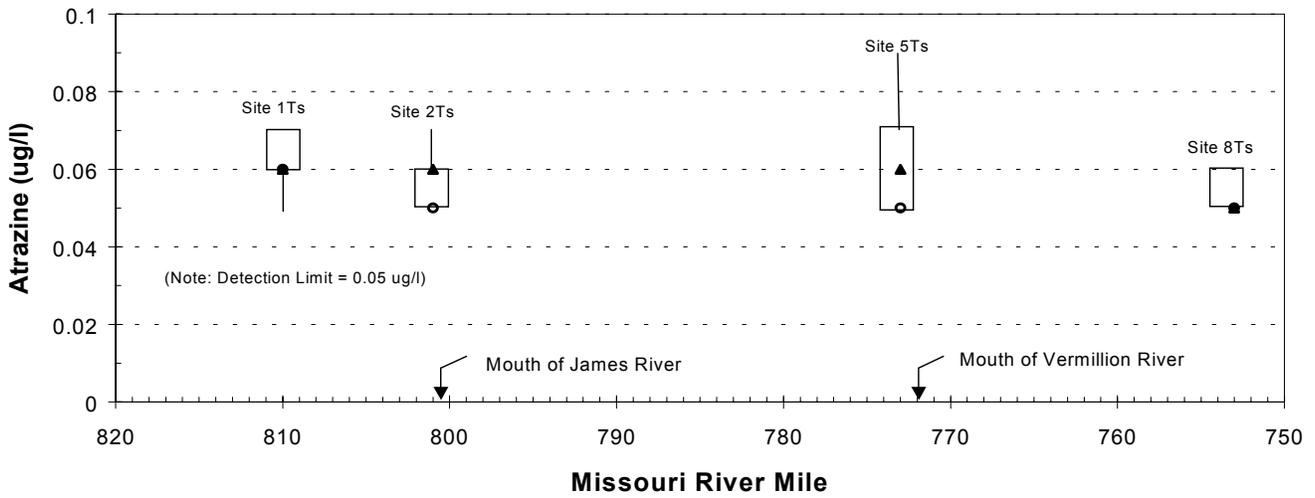
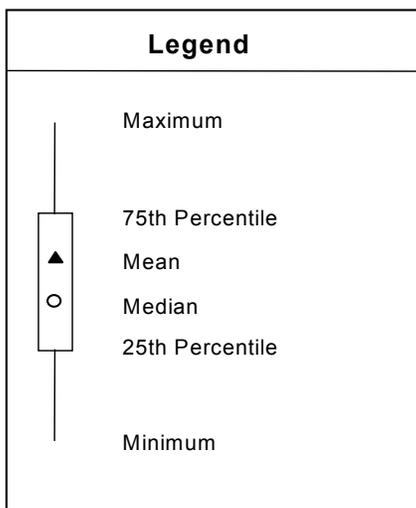
**Figure 9.** Box plots of water quality parameters monitored at Sites 1Ts, 2Ts, 5Ts, and 8Ts during the scoping study.

Monitoring results were used to construct box plots for each parameter measured, except alachlor and metolachlor, at Sites 1Ts, 2Ts, 5Ts, and 8Ts during the scoping study. As noted previously, all samples analyzed for alachlor and metolachlor were below method detection limits. The constructed parameter box plots were plotted, by site, on a graph where the x-axis represented Missouri River mileage points (Plate 9). Based on this graphical representation it was determined that water temperature, pH, total organic carbon, total Kjeldahl nitrogen, total ammonia, nitrate-nitrite, chlorophyll *a*, and atrazine exhibited no noticeable longitudinal variation through the MNRR reach; while, dissolved oxygen, conductivity, Secchi depth, turbidity, total suspended solids, and total phosphorus did. For the six parameters that exhibited longitudinal variation it was concluded that no noticeable difference existed between Sites 1Ts and 2Ts; however, there was a noticeable difference between Sites 2Ts and 5Ts for all six parameters and Sites 5Ts and 8Ts for all the parameters except conductivity. Statistical assessment (two-tailed, paired t-test) of the measured values obtained at Sites 2Ts and 5Ts

where there was a noticeable difference observed in Plate 9, found the following significance levels (rounded to two significant digits): conductivity ( $p = 0.02$ ), dissolved oxygen ( $p = 0.05$ ), Secchi depth ( $p = 0.03$ ), turbidity ( $p < 0.01$ ), total suspended solids ( $p < 0.01$ ), and total phosphorus ( $p < 0.01$ ). A similar assessment of the measured values obtained at Sites 5Ts and 8Ts found the following significance levels: dissolved oxygen ( $p = 0.04$ ), Secchi depth ( $p = 0.05$ ), turbidity ( $p = 0.02$ ), total suspended solids ( $p = 0.01$ ), and total phosphorus ( $p < 0.01$ ).

The differences between Sites 2Ts and 5Ts and Sites 5Ts and 8Ts for all the noted parameters except possibly dissolved oxygen are believed due to the respective inflows of the James and Vermillion Rivers. The differences in dissolved oxygen may be due to other factors. It is noted that the Sites 1Ts and 2Ts were sampled in the early morning, Site 5Ts was sampled around noon, and Site 8Ts was sampled in the late afternoon. The dissolved oxygen percent saturation levels measured at Sites 1Ts and 2Ts were in the low 90's, at Site 5Ts it was in the high 90's, and at Site 8Ts it was above 100%. This downstream pattern of increasing dissolved oxygen concentrations and percent saturations could be reflective of the "normal" diurnal changes in dissolved oxygen due to photosynthesis and respiration. It is also noted that the pattern could be the result of reoxygenation of lower oxygenated water discharged from the reservoir through Gavins Point Dam or a possible bias introduced into the measurements from meter drift.

The inflow of the James River appears to have a significant influence on turbidity levels in the Missouri River (Plate 9). During the scoping study a turbidity plume was observed below the mouth of the James River in the side channel of the Missouri River into which it enters. This turbidity plume can visually be seen in the 1997 orthophoto of the area (Plate 16). Mean turbidity, Secchi depth, and conductivity values calculated from the data collected at Sites 2Ts, 3, 3T1, 3T2, 3T3, 3T4, 4B and 5Ts are given in Table 6. The plume formed below the James River stays relatively intact throughout the entire length of the side-channel of the Missouri River into which it flows. As seen in the data collected at Site 4B, the plume still exists within the Missouri River one-half mile below where the side-channel rejoins the main river, but is dissipating (Table 6).

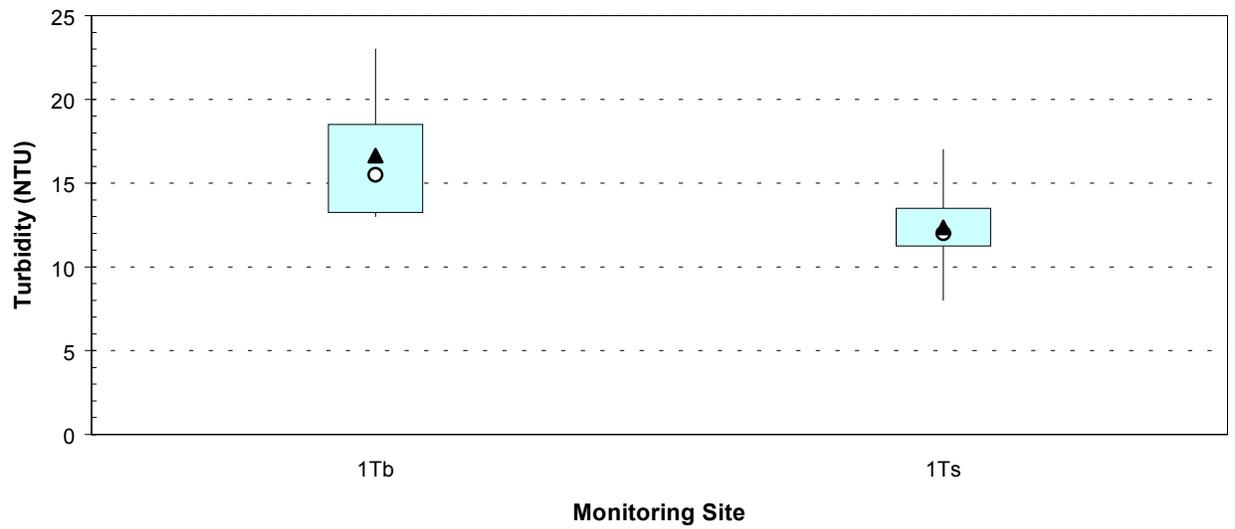
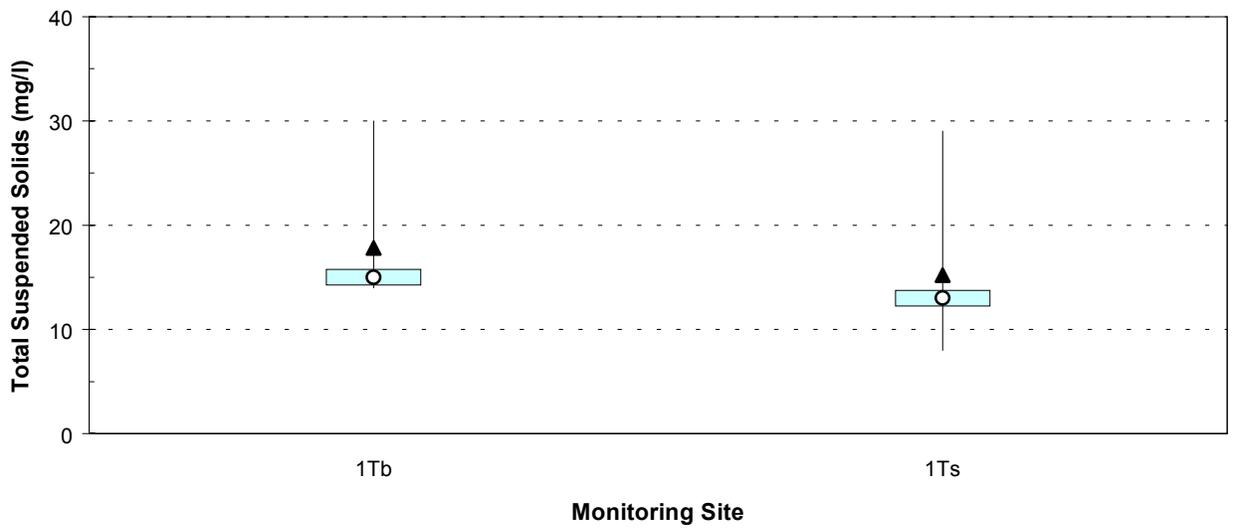
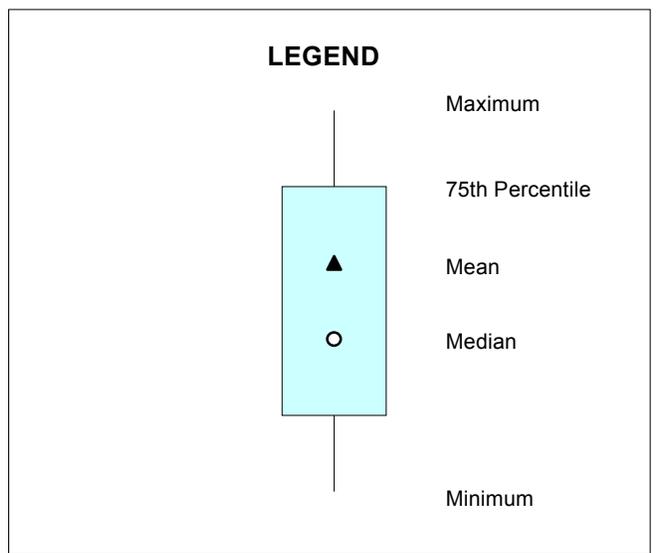
**Figure 10.** Boxplots of turbidity and total suspended solids levels for the near-bottom and near-surface thalweg samples collected at monitoring location 1.

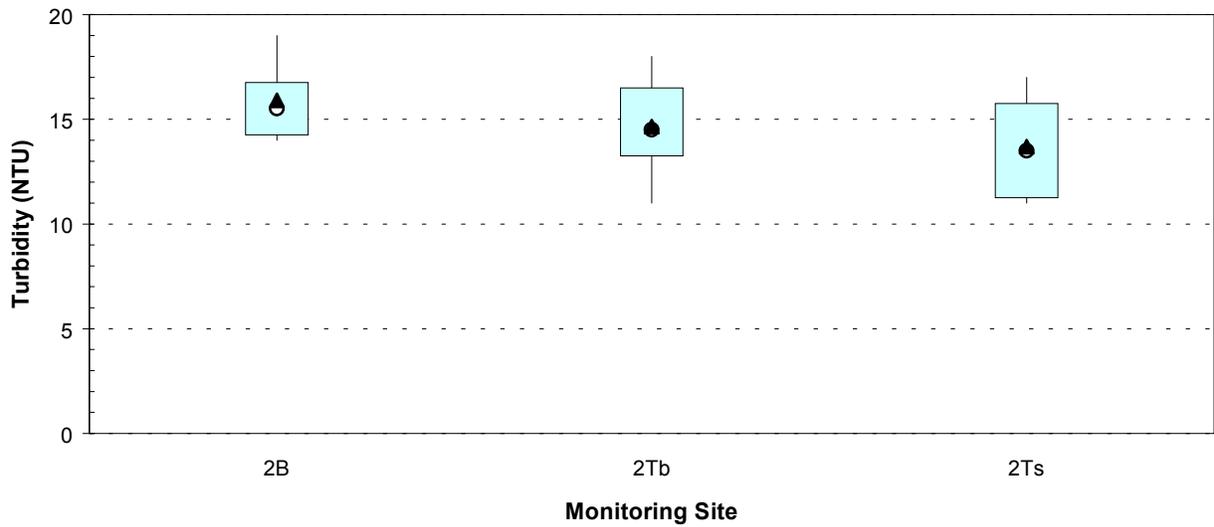
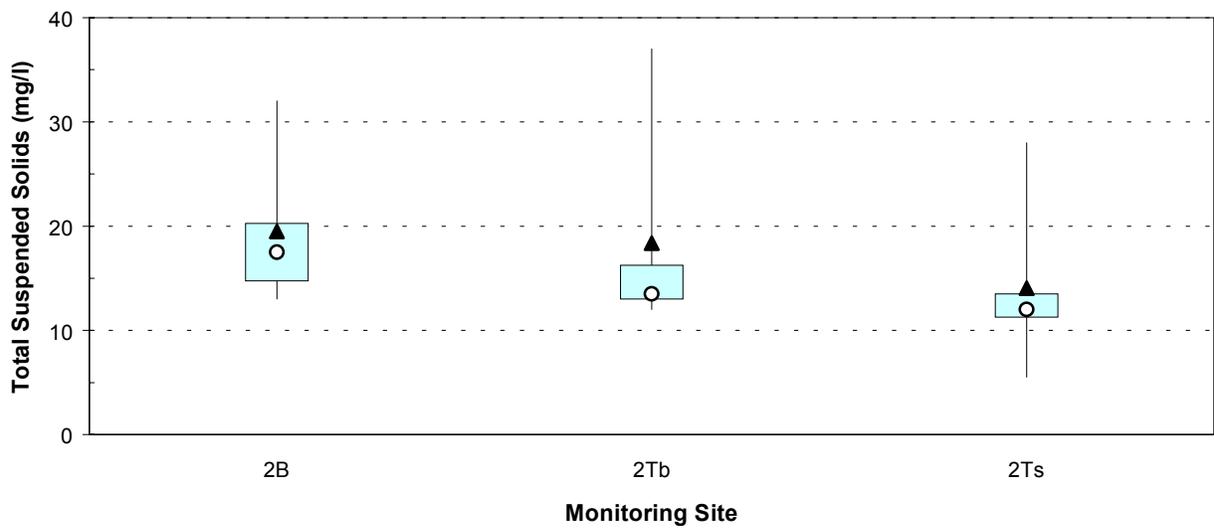
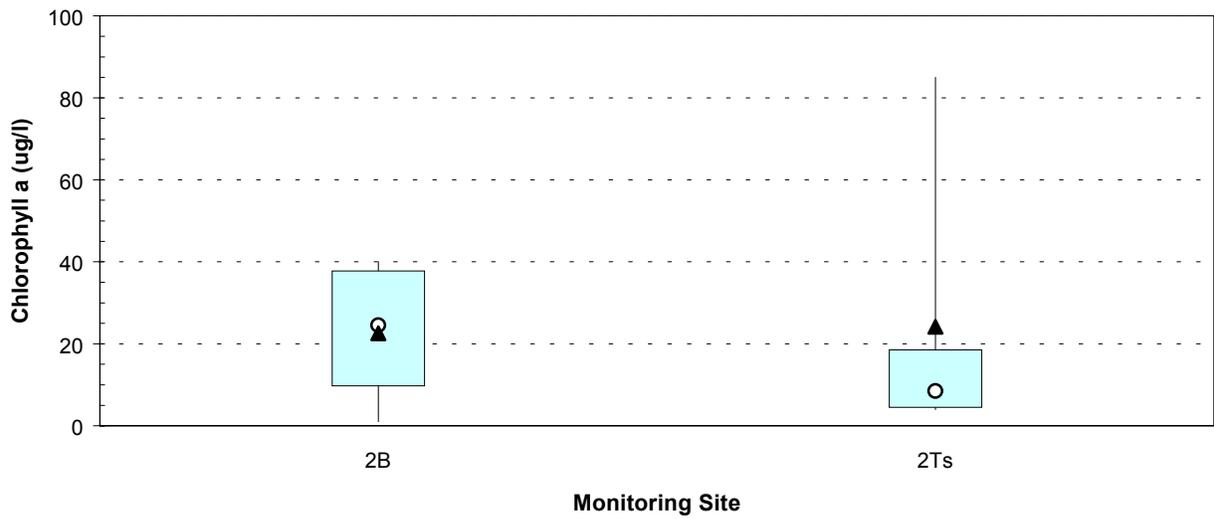
**Figure 11.** Boxplots of turbidity, total suspended solids, and chlorophyll a levels for the backwater and near-bottom and near-surface thalweg samples collected at monitoring location 2.

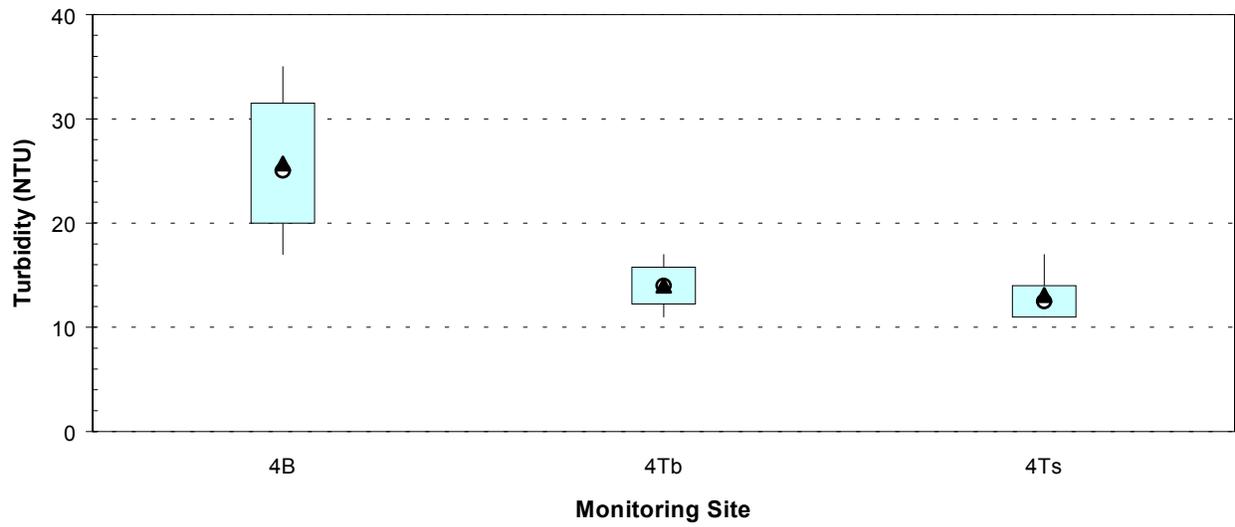
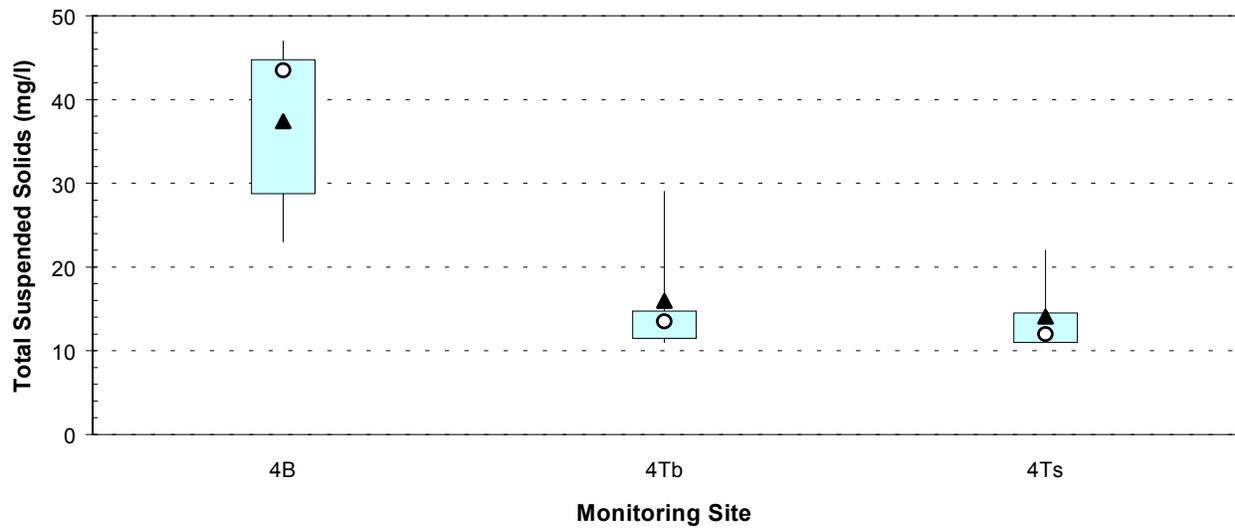
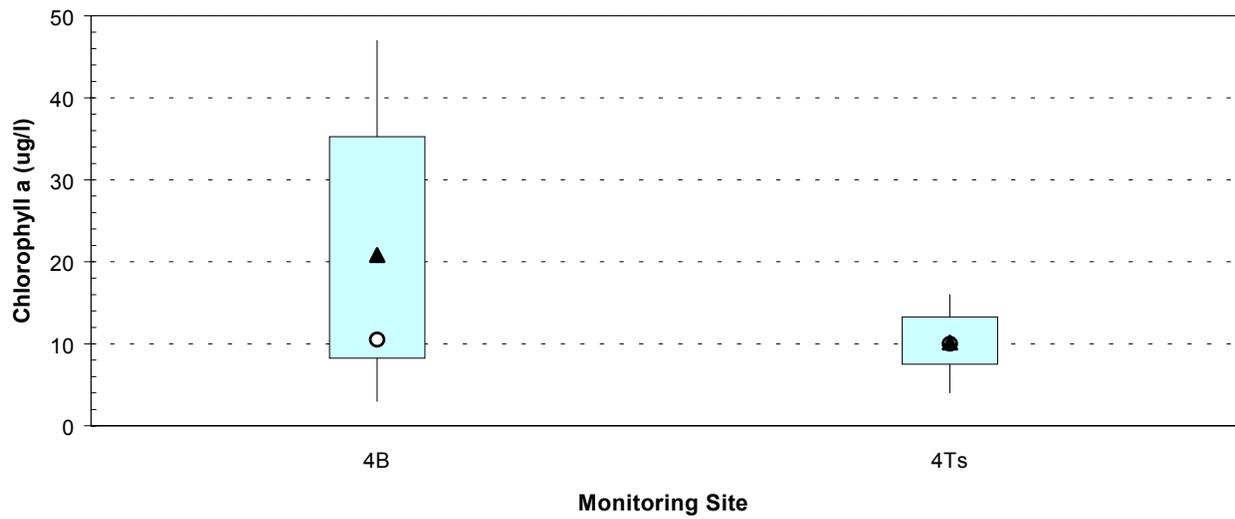
**Figure 12.** Boxplots of turbidity, total suspended solids, and chlorophyll *a* levels for the backwater and near-bottom and near-surface thalweg samples collected at monitoring location 4.

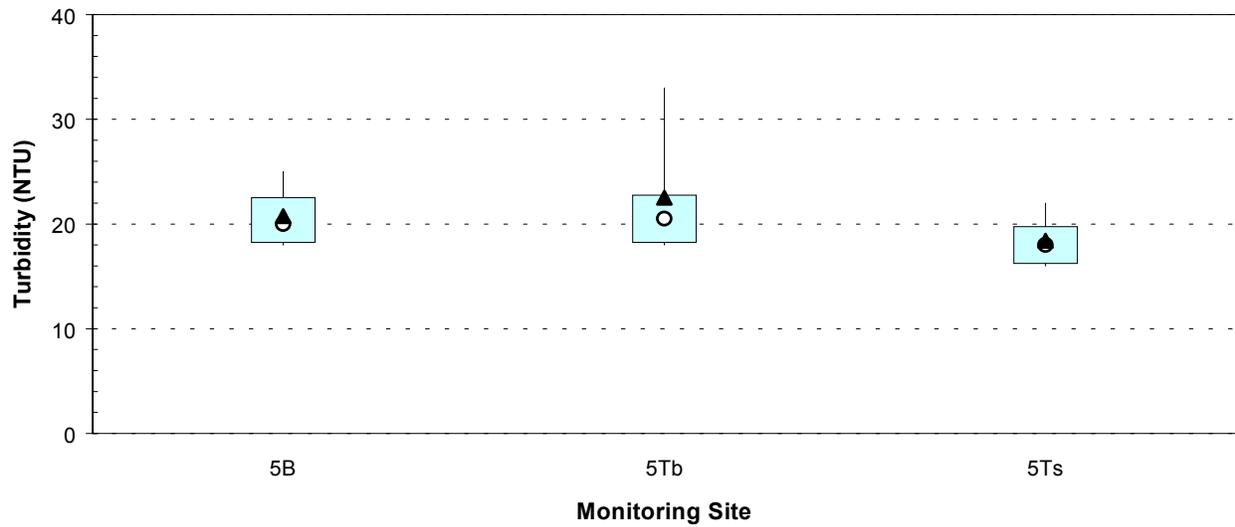
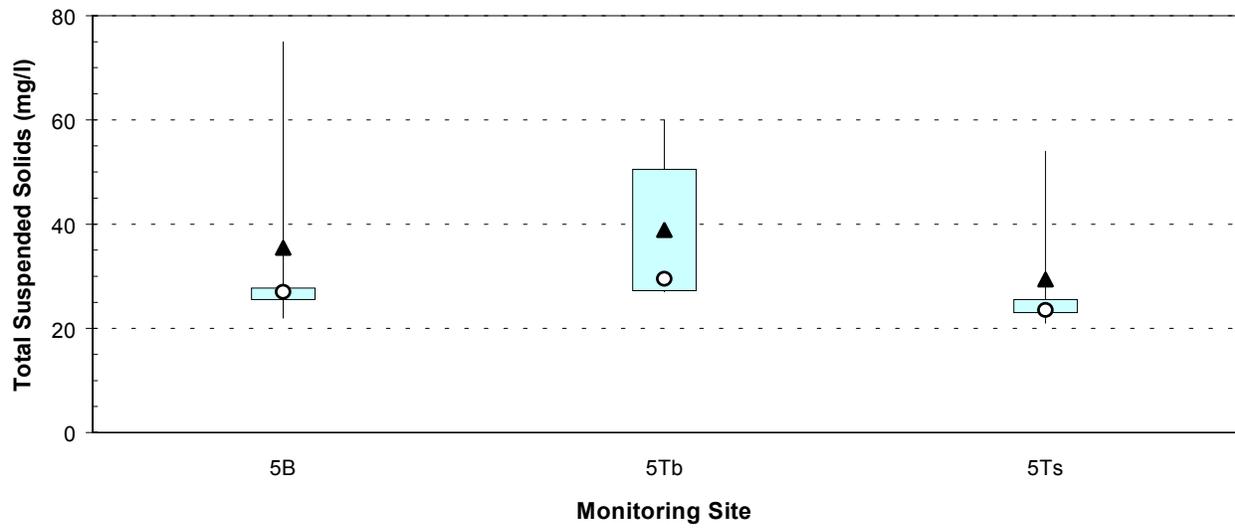
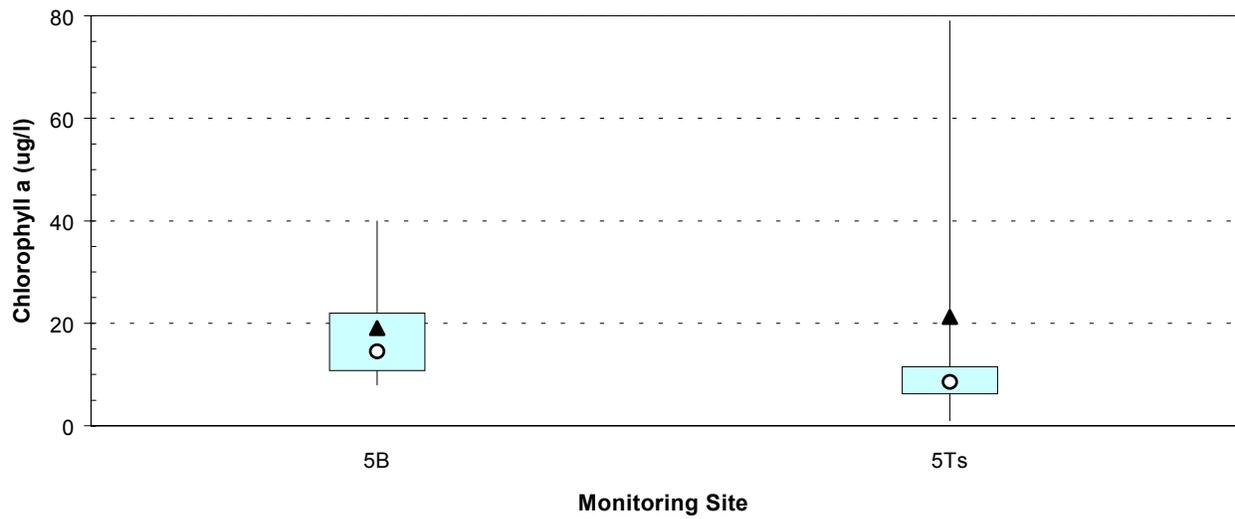
**Figure 13.** Boxplots of turbidity, total suspended solids, and chlorophyll *a* levels for the backwater and near-bottom and near-surface thalweg samples collected at monitoring location 5.

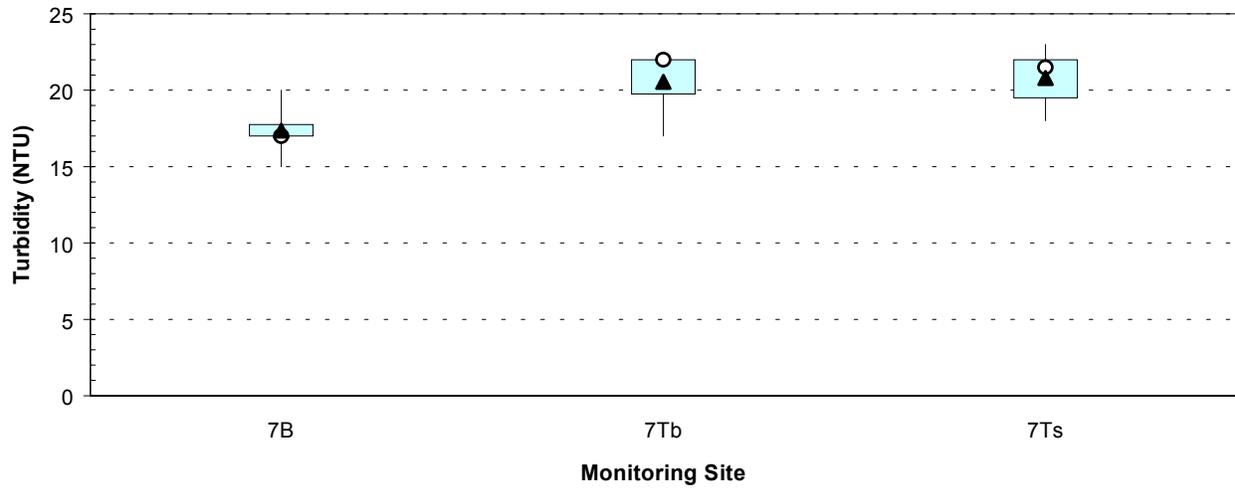
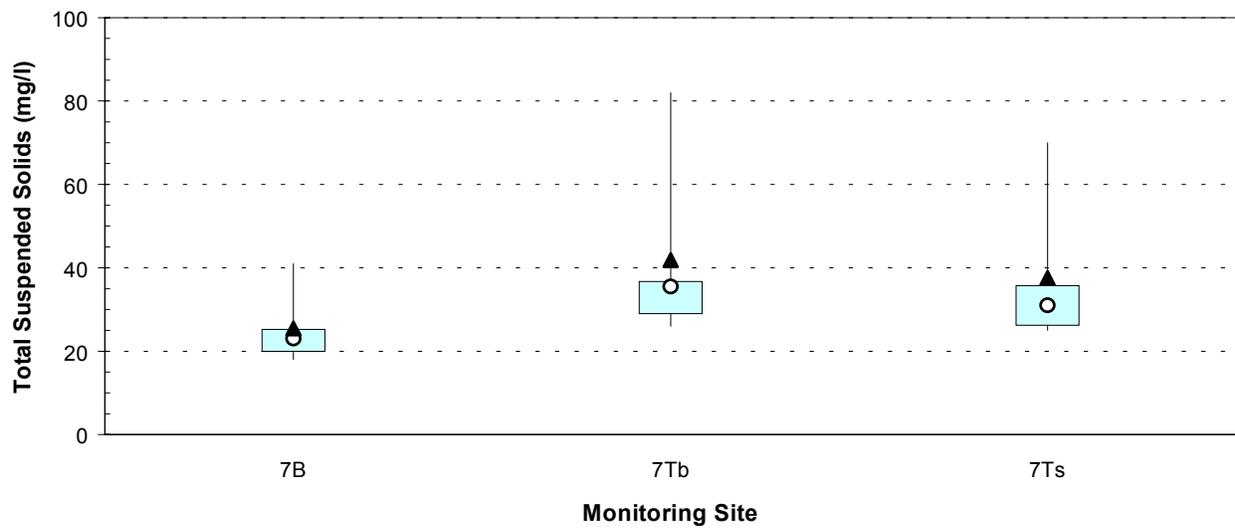
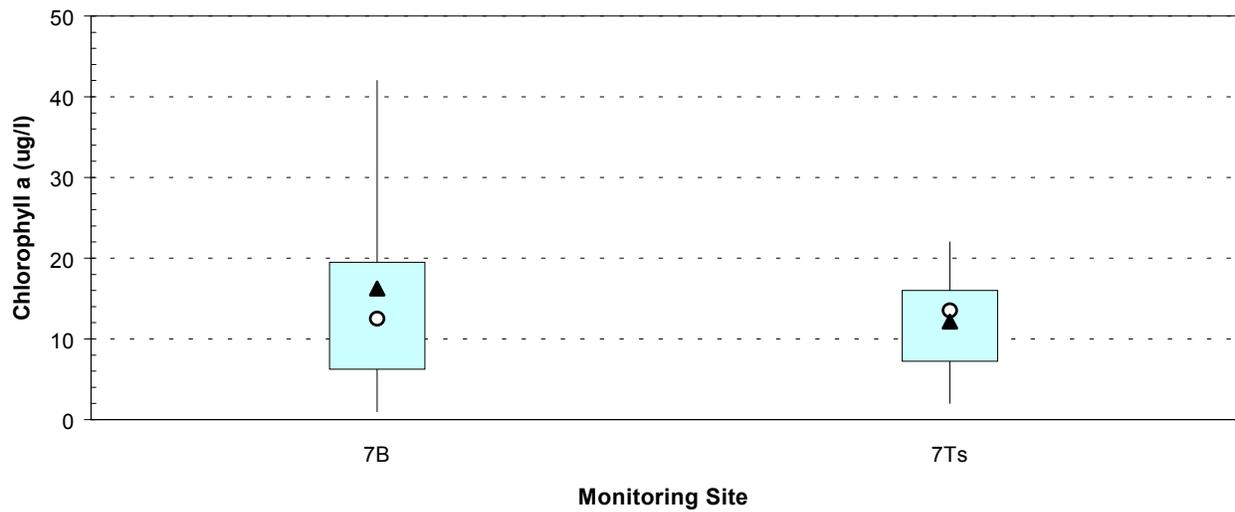
**Figure 14.** Boxplots of turbidity, total suspended solids, and chlorophyll a levels for the backwater and near-bottom and near-surface thalweg samples collected at monitoring location 7.

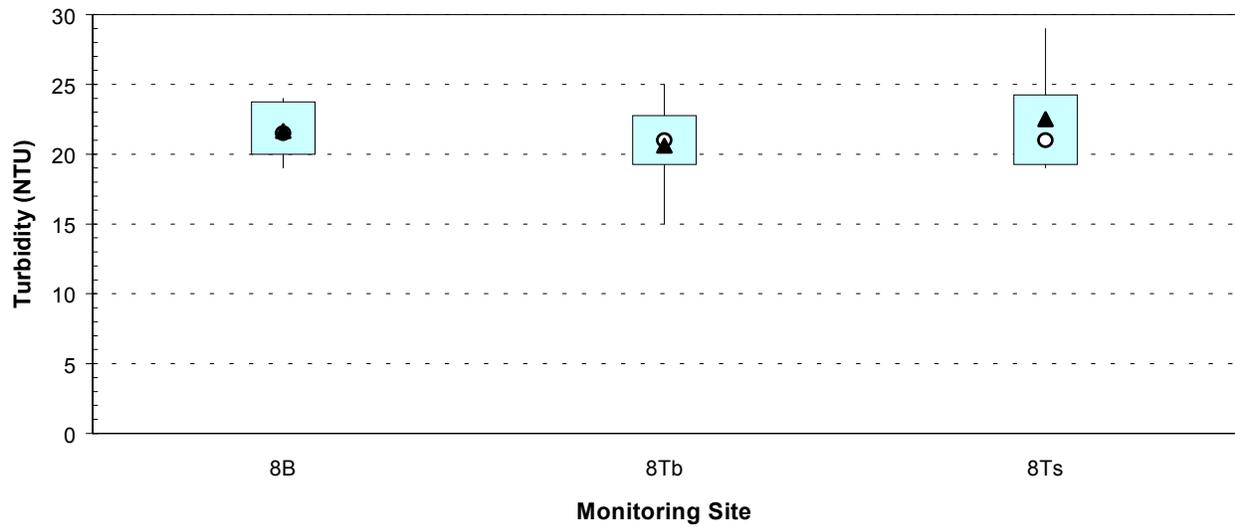
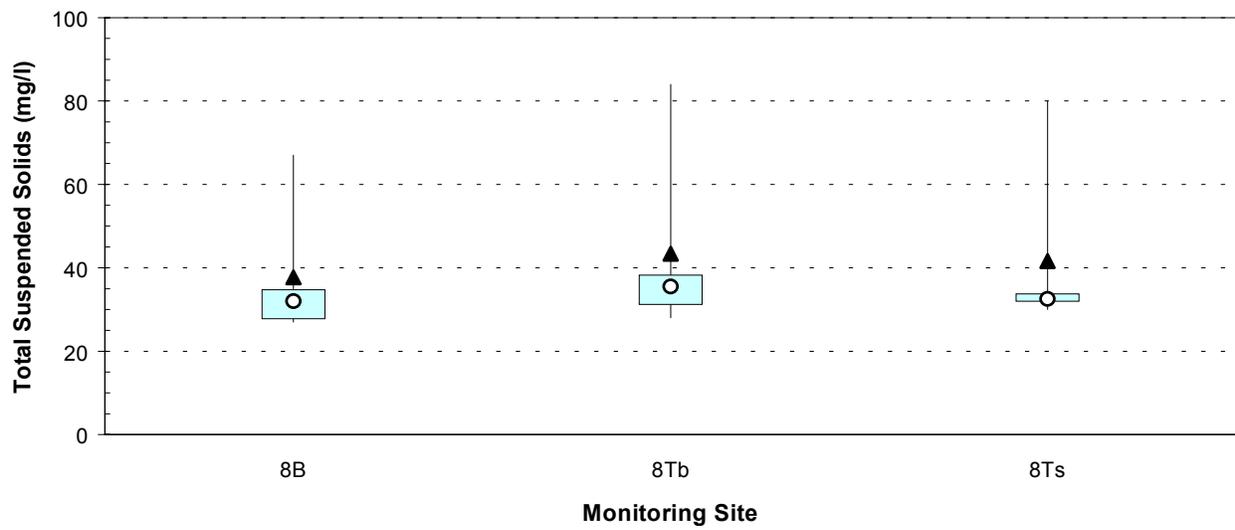
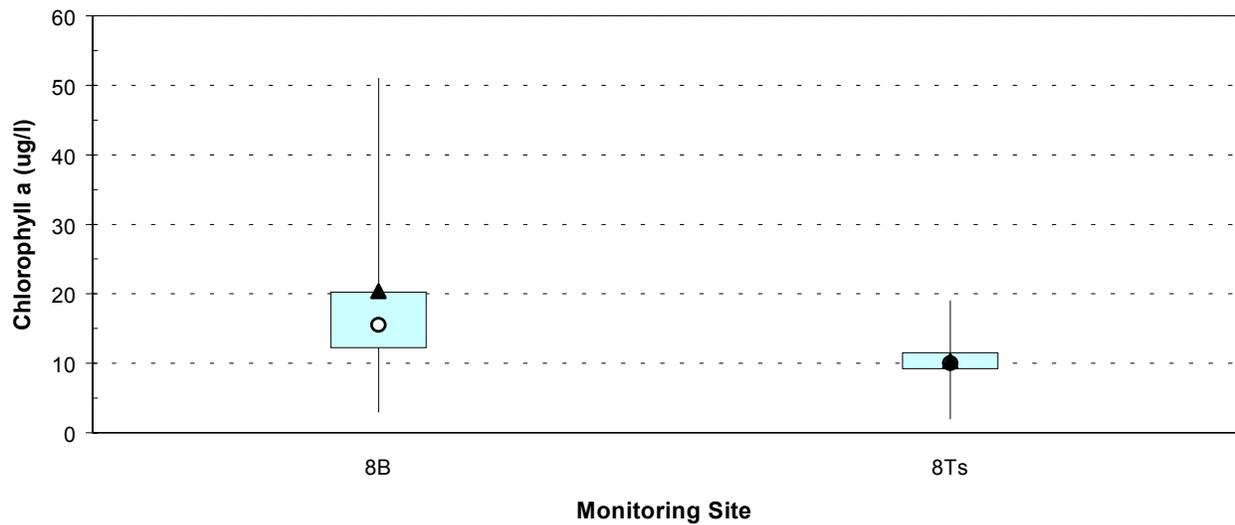
**Figure 15.** Boxplots of turbidity, total suspended solids, and chlorophyll *a* levels for the backwater and near-bottom and near-surface thalweg samples collected at monitoring location 8.
