**A SCOPING STUDY OF WATER QUALITY CONDITIONS  
IN THE MISSOURI NATIONAL RECREATIONAL RIVER  
REACH FROM NEAR GAVINS POINT DAM TO PONCA  
STATE PARK, NEBRASKA**

**Water Quality Unit  
Water Control and Water Quality Section  
Hydrologic Engineering Branch  
Engineering Division  
Omaha District  
U.S. Army Corps of Engineers**

**March 2002**

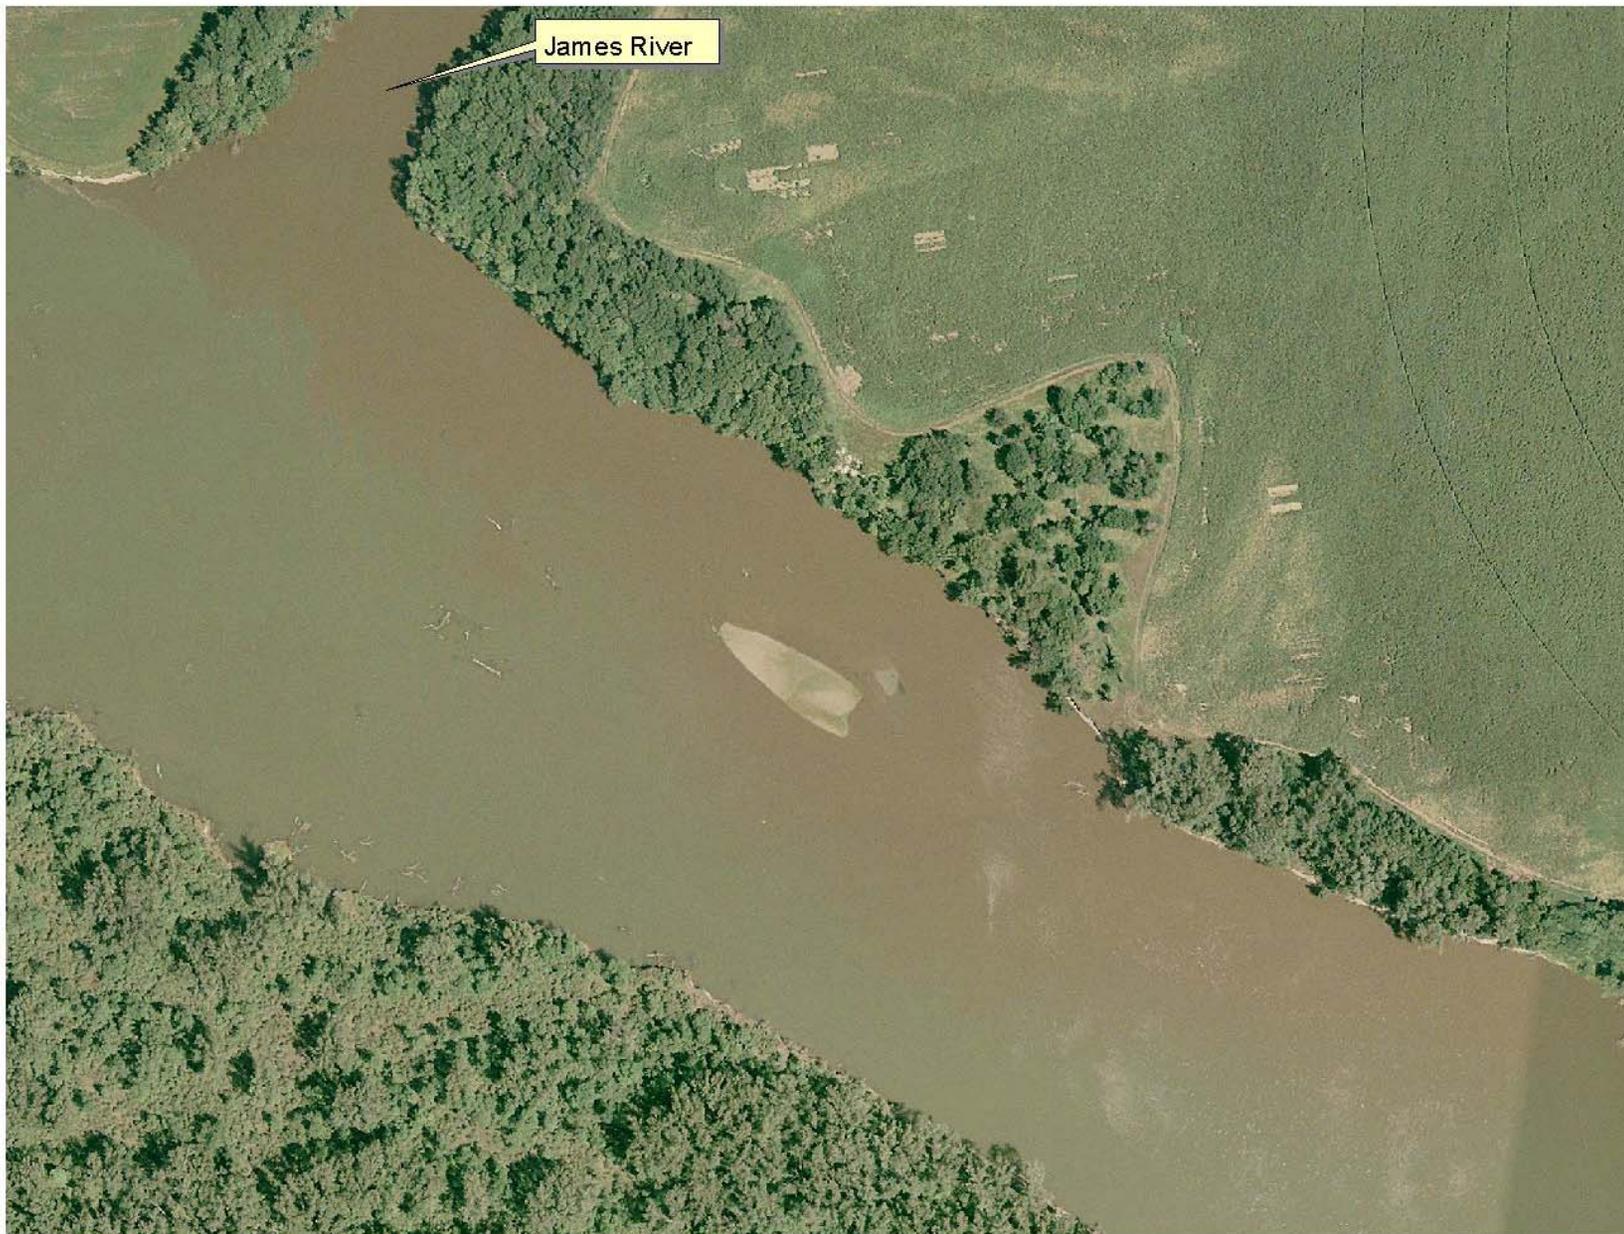
**Plate 16.** Area near the mouth of the James River as it enters a side channel of the Missouri River as depicted in a 1997 orthophoto of the area.

The inflow of the James River appears to have a significant influence on turbidity levels in the Missouri River (Plate 9). During the scoping study a turbidity plume was observed below the mouth of the James River in the side channel of the Missouri River into which it enters. This turbidity plume can visually be seen in the 1997 orthophoto of the area (Plate 16). Mean turbidity, Secchi depth, and conductivity values calculated from the data collected at Sites 2Ts, 3, 3T1, 3T2, 3T3, 3T4, 4B and 5Ts are given in Table 6. The plume formed below the James River stays relatively intact throughout the entire length of the side-channel of the Missouri River into which it flows. As seen in the data collected at Site 4B, the plume still exists within the Missouri River one-half mile below where the side-channel rejoins the main river, but is dissipating (Table 6).
